# **Energy Code Enforcement and Compliance in Pennsylvania: Lessons from the Field**

July 2008

MikeTurns

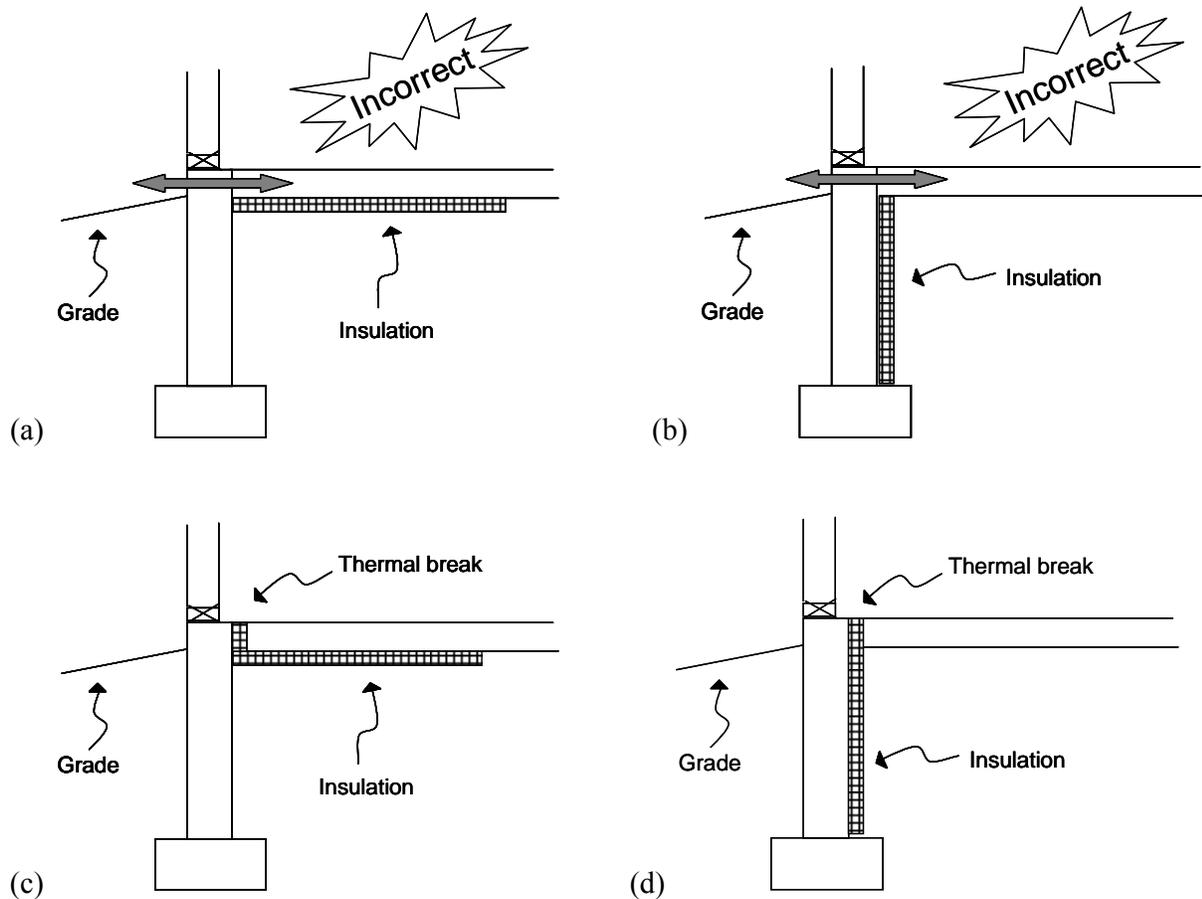
**Figure 3.2: Slab insulation details**

Section 502.2.1.4 of the 2003 IECC and section 402.2.7 of the 2006 IECC both state that slab insulation must extend downward from the top of the slab, thus achieving a thermal break. The PA-Alt also has this requirement, but a ½" thermal break is acceptable rather than the two inches that would be required to achieve the full required R-value. This detail is not usually shown on plans thus leaving the plan reviewer no way to help ensure that the slab insulation will be installed properly.

Drawings (a) and (b) depict improper installation of slab installation. These details do not contain a thermal break between the slab and the footer leading to energy loss and a cold slab (in winter). Drawings (c) and (d) depict proper installation of slab insulation as the insulation extends downward from the top of the slab creating a thermal break. To reduce problems with flooring installation, the IRC and IECC allow the top of the insulation to be cut at a 45° angle away from the wall. The PA-Alt allows for a ½" thermal break instead of the full required R-value. Insulation may also be placed on the exterior of the foundation, but must still extend from the top of the slab. Slab insulation is not required in jurisdictions designated by the code official as having heavy termite infestation.

**Recommendation 3:** Plan reviewers should identify and mark the building thermal envelope on the plans for each area to be constructed ensuring that it is continuous. Also, check for continuity of insulation in slabs, foundation walls, stairwells and other architectural details where applicable.

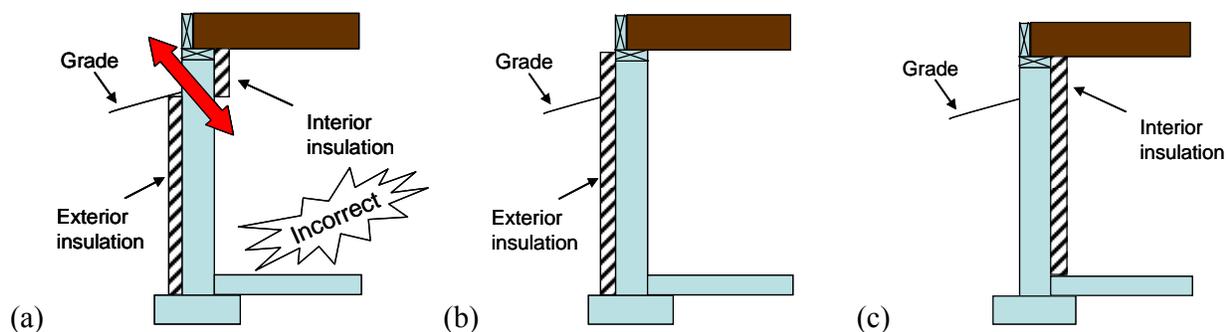
**Figure 3.3: Thermal bridging due to improper installation of basement wall insulation and two methods of proper installation.**

Another issue that came up during discussions with code officials was whether or not it is acceptable to insulate a foundation wall on the inside for the above-grade portion of the wall and on the exterior of the wall for below-grade portions. While the PHRC team did not witness this during this project, discussions with code officials indicate that the practice is common in some areas of the Commonwealth. Discontinuous foundation wall insulation leads to a direct conductive pathway from the inside to the outside resulting in significant heat loss during the heating season.

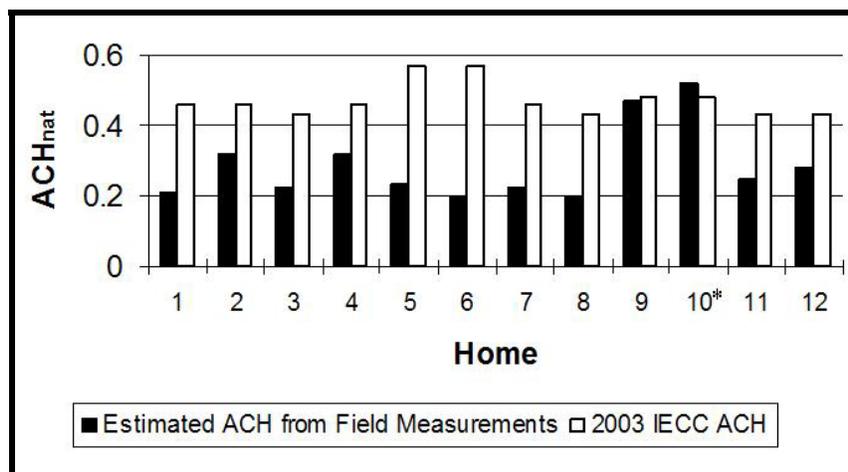
**Figure 4.1: Sample home infiltration rates compared to 2003 IECC Reference Home**

The average infiltration rate of sample homes was significantly lower than either of these standards (However, as a target for infiltration rates the IECC does set forth a very lofty goal.) Infiltration rates of sample homes are shown in Figures 4.1 and 4.2 along with the rates of the 2003 and 2006 reference homes. It should be noted that home #10 officially fell under the commercial energy code because it was a four-story townhouse. This is somewhat of a technicality. So, in this report, this home is not treated differently than the other homes in this study and is compared with the residential reference homes.

Figure 4.1 shows estimated infiltration rates, based on blower door tests, of twelve homes compared with the infiltration rates used in the standard design in the 2003 IECC systems analysis path (Chapter 4). The black bars represent the estimated ACH of the twelve homes in this sample and the white bars represent the ACH of the 2003 IECC reference home (which varies by climate).

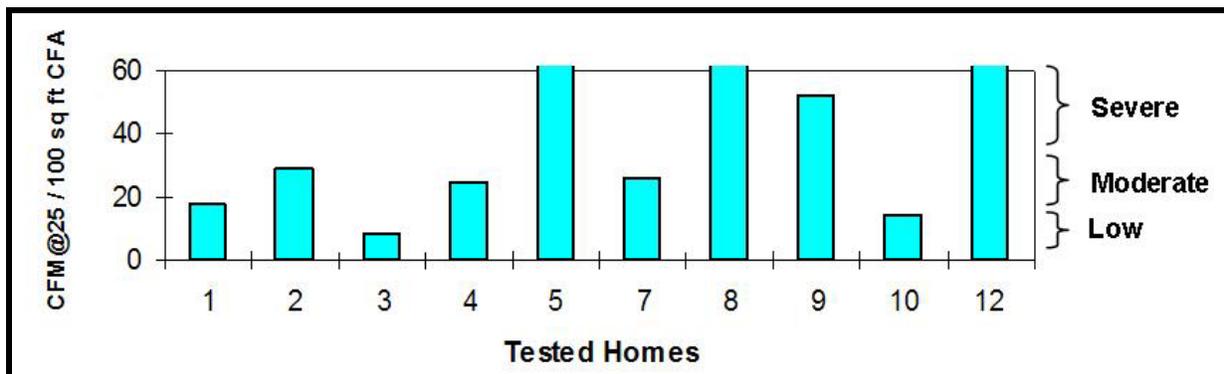
**Figure 4.3: Total duct leakage in CFM as a proportion of conditioned floor area**

Duct leakage to outside of the building thermal envelope also varied widely. Six homes had duct leakage to outside at levels close to, or lower than, required by the federal ENERGY STAR Qualified Homes program. It should be noted that two of these duct systems (homes 5 and 7) had leaky ducts, but all ducts

were located entirely within the building thermal envelope. Four duct systems had large amounts of duct leakage to the outside with greater than 20 CFM per 100 sq ft CFA. One of these four systems was so leaky that adequate pressure could not be achieved for testing.

Figure 4.3 shows total duct leakage in cubic feet per minute (CFM) when tested with a duct blaster at a pressure of -25 Pa. This measure is standardized by the conditioned floor area of the home in which the ducts were located. Bars that extend past the border of the graph indicate that duct leakage was so extensive that a useful test pressure could not be reached. Homes 6 and 11 are not shown because no duct testing was performed due to technical infeasibility.

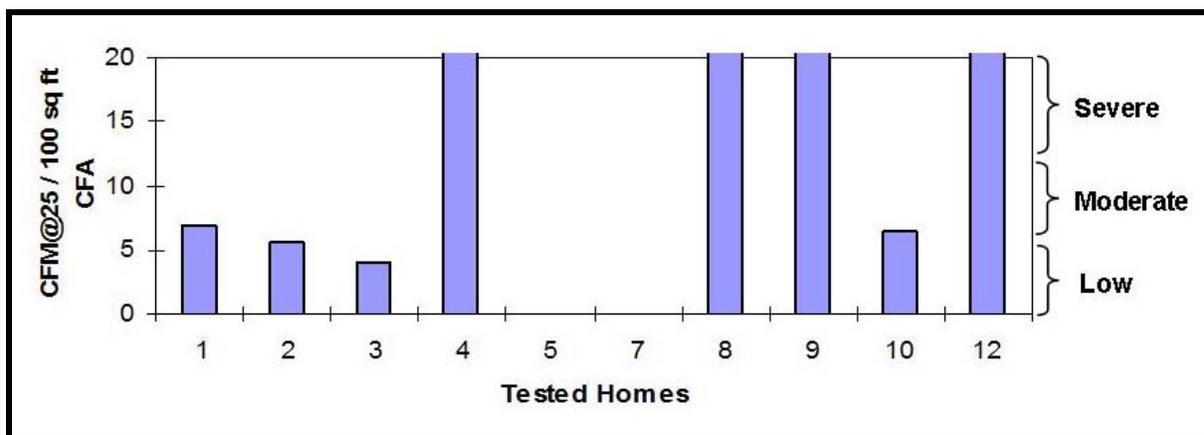
**Figure 4.4: Duct leakage to outside as a proportion of conditioned floor area**

Figure 4.4 shows duct leakage to outside the building thermal envelope in cubic feet per minute (CFM) when tested with a duct blaster at a pressure of -25 Pa. The conditioned space was also depressurized to -25 Pa to isolate duct leakage to the outside. This measure is standardized by the conditioned floor area of the home in which the ducts were located. Bars that extend past the border of the graph indicate duct leakage greater than 20 CFM/100 sq ft CFA or that the test pressure could not be achieved. Homes 6 and 11 are not shown because no duct testing was performed due to technical infeasibility.

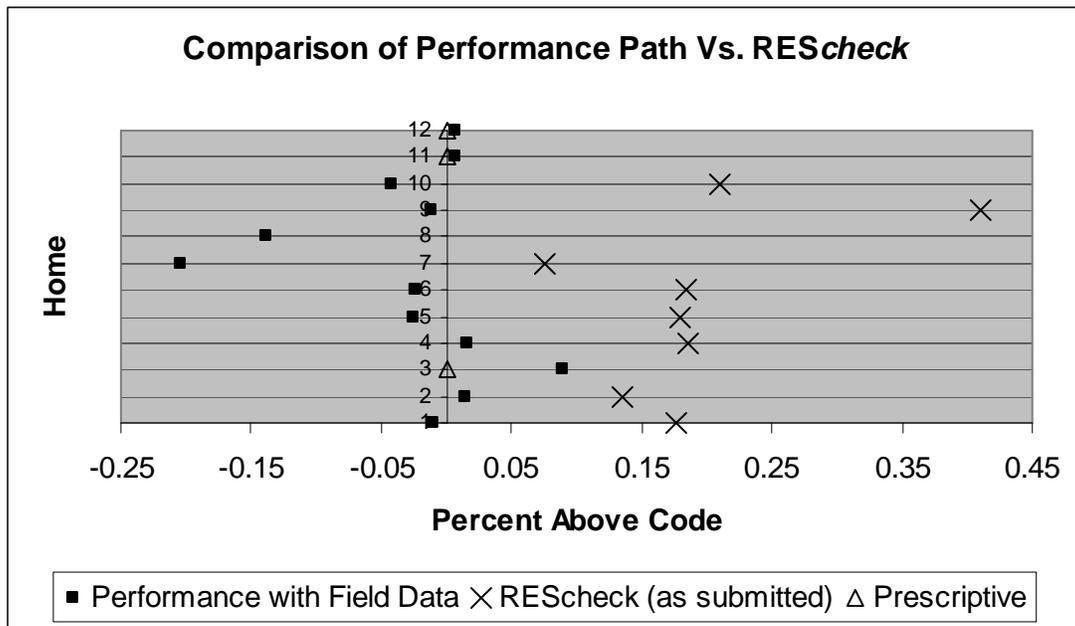
**Figure 4.5: Comparison of performance path vs. REScheck**

These estimates of energy consumption relative to a code baseline differ greatly from comparisons to code using REScheck. Homes averaged 3.2% below code with performance modeling. On the other hand, REScheck Compliance Certificates submitted by builders claimed an average of 19% above code. Given this disparity it is likely that builders and code officials have a perception that typical homes have better energy performance than they actually do.

Figure 4.5 shows the difference between the percent above code claimed by builders using REScheck with the percent above or below code when using a computer simulation with field data. Home 10 is a comparison of the commercial energy code software COMcheck results with the residential performance path because COMcheck was (correctly) used instead of REScheck. Given the same inputs REScheck results would not have been as favorable and the discrepancy reduced.
