**Performance of Structural Insulated
Panels with Different Fasteners
and Splines Under Monotonic
and Cyclic Loading**

**Stefanie Terentiuk
Ali M. Memari**

May 2011

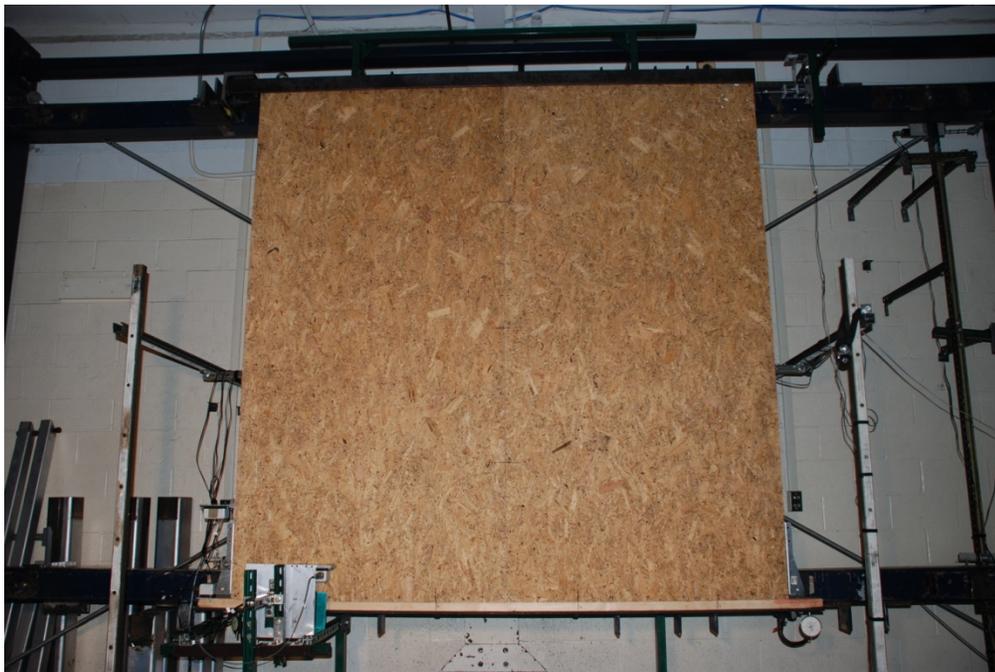
Figure 3.2: Photograph of test facility with wall in place

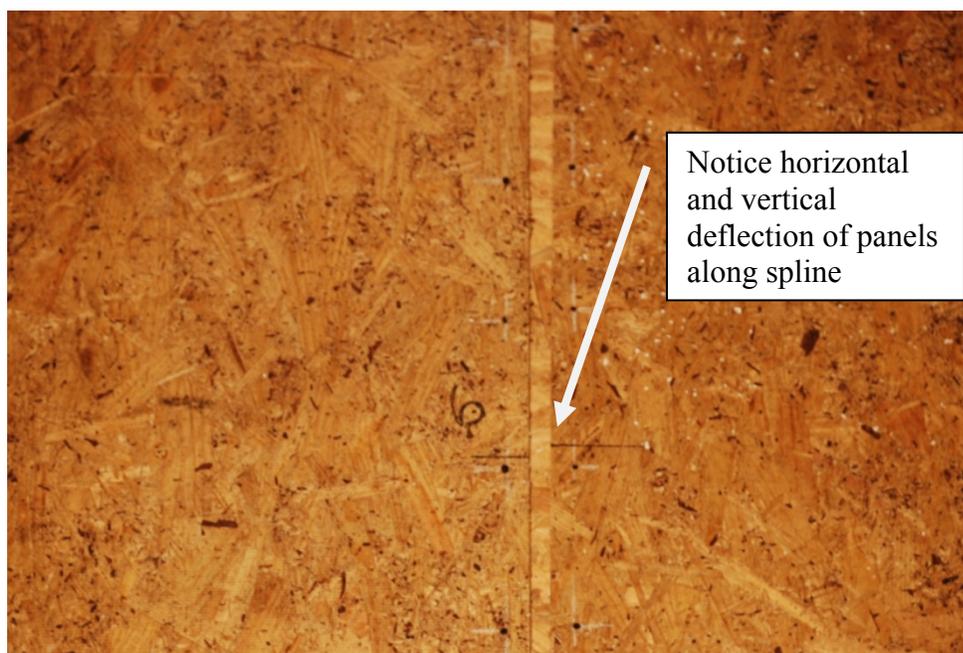
Figure 4.25: Deflection of SIP panels six feet high on Specimen A4-1C after cyclic loading

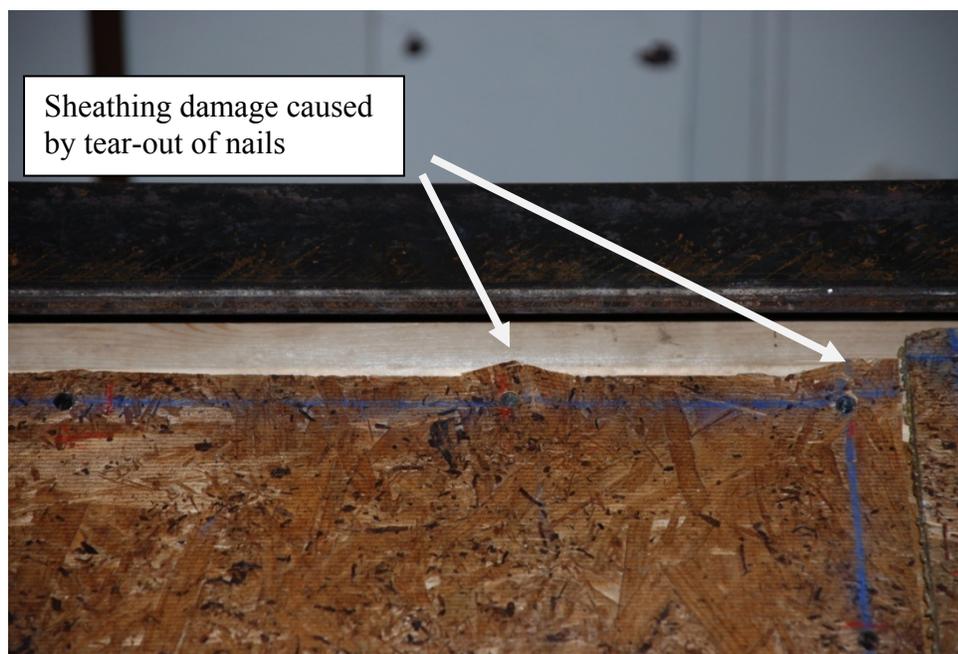
Figure 4.37: Sheathing damage along top plate of Specimen A1-1M

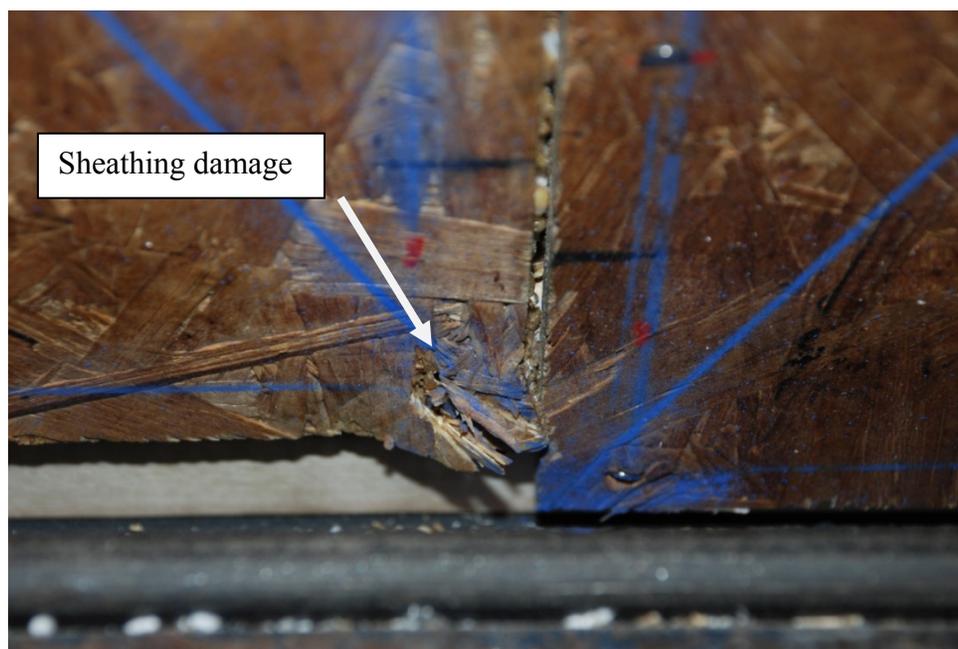
Figure 4.38: Sheathing damage at inner corner of panels along base plate of Specimen A1-1M

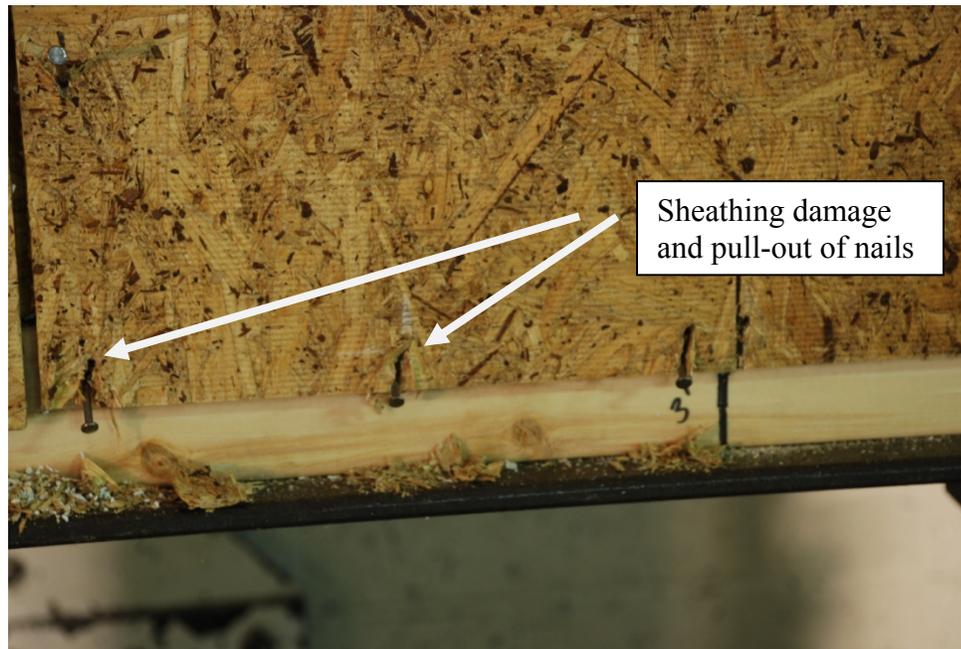
Figure 4.48: Sheathing damage along base plate of Panel 1 of Specimen A1-1C after Fatigue 3

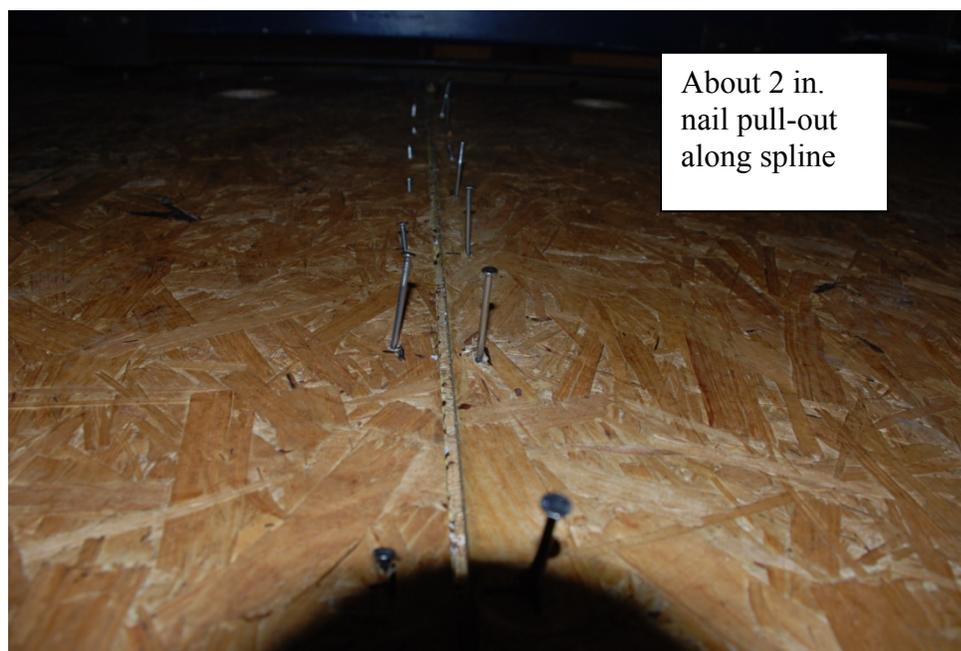
Figure 4.49: Nail pull-out along spline of Specimen A1-1C after Fatigue 3

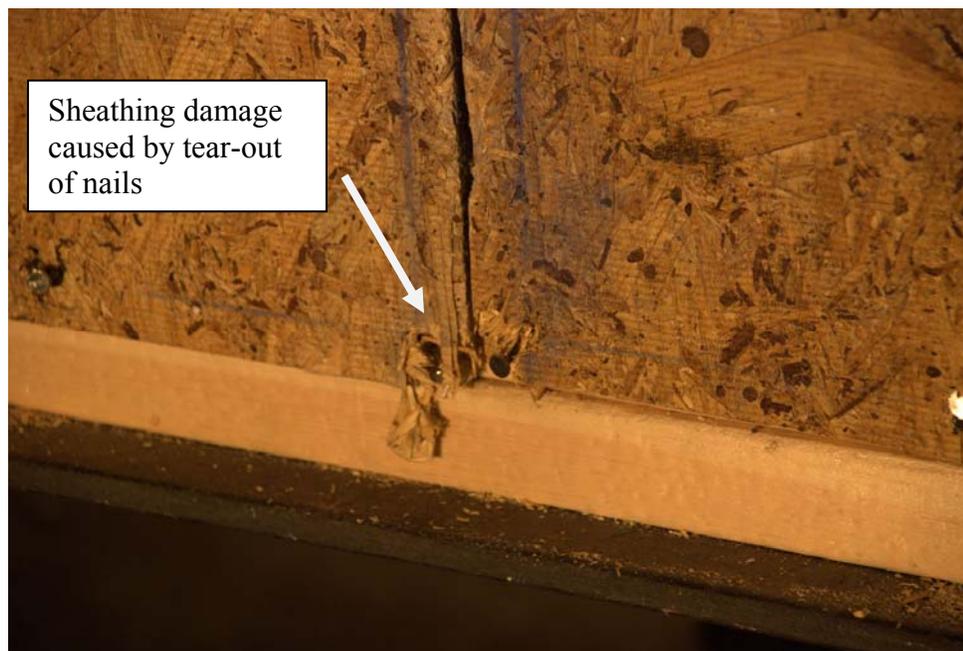
Figure 4.76: Sheathing damage at inner corner of panels along base plate after cyclic loading of Specimen A1Internal-4C

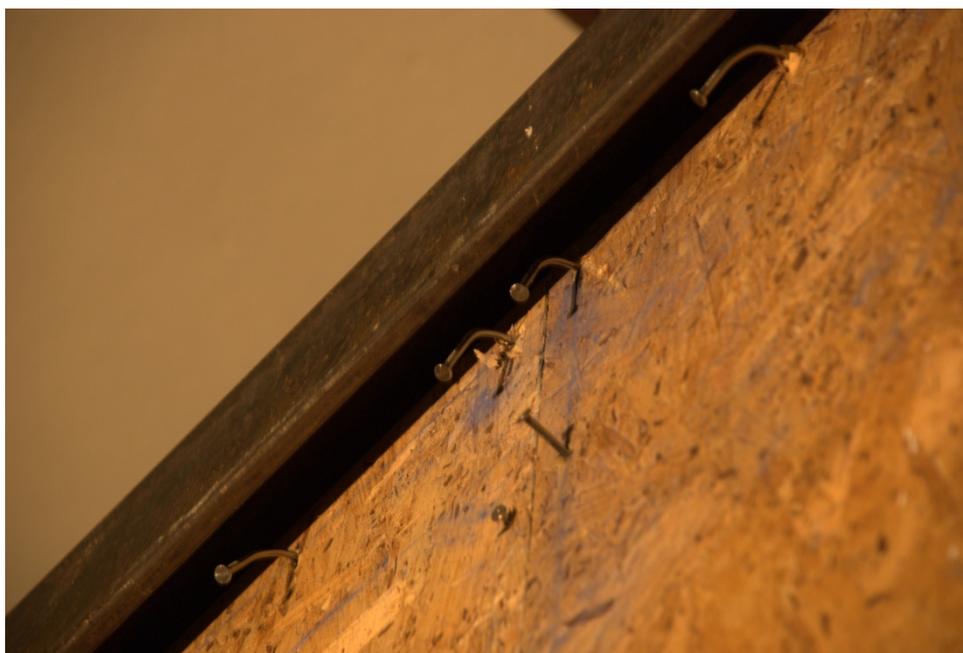
Figure 4.83: Nail pull-out along spline and top plate of Specimen A1Internal-4C after Fatigue 3

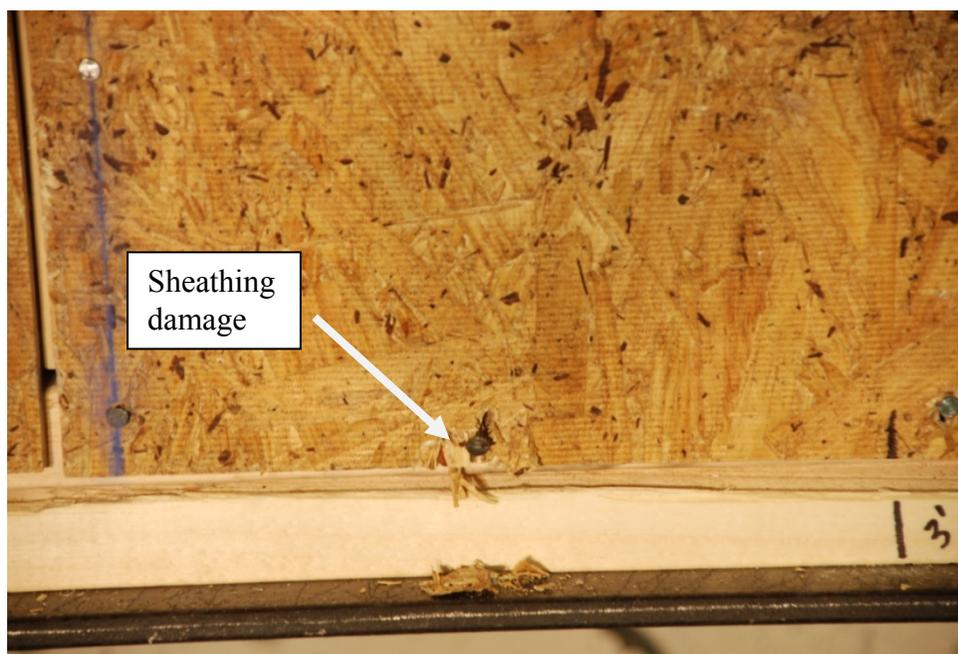
Figure 4.88: Sheathing damage along base plate after cyclic loading of Specimen B-1C

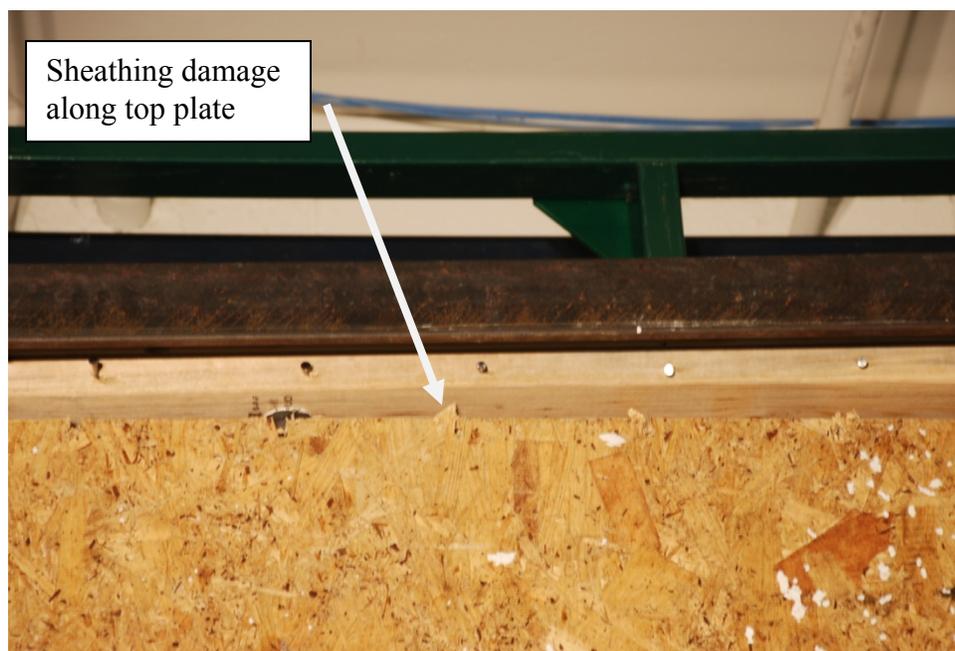
Figure 4.95: Sheathing failure along top plate of Specimen B-1C after Fatigue 1

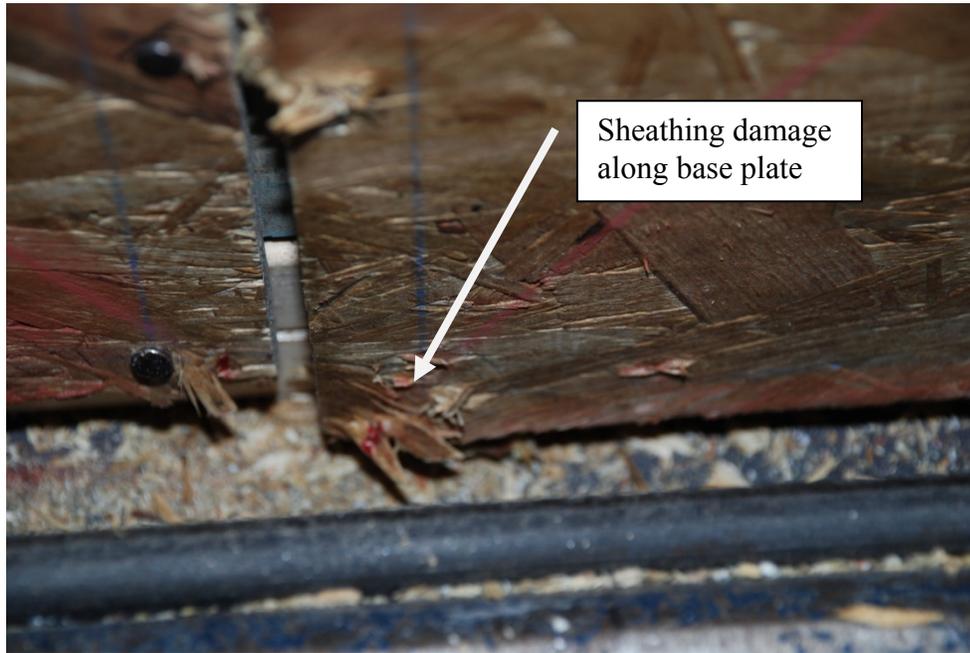
Figure 4.122: Damage to sheathing along base plate of Specimen C-2C after Fatigue 2 test
