A Brief Discussion on Fire Safety Issues of Subdivided Housing Units in Hong Kong

K.K. Leung¹ and C.L. Chow²

A total of 10 buildings including 8 residential buildings and 2 industrial buildings were surveyed with their potential fire hazards inspected (Leung 2014). These buildings are distributed in different districts in the downtown areas of Hong Kong, including Yau Ma Tei, Fanling, To Kwa Wan, North Point, Sham Shui Po, Mongkok, Tai Po and Hung Hom labelled as R1 to R8 for residential buildings; and labelled as I1 and I2 for industrial buildings in Kwun Tong in Tsuen Wan respectively.

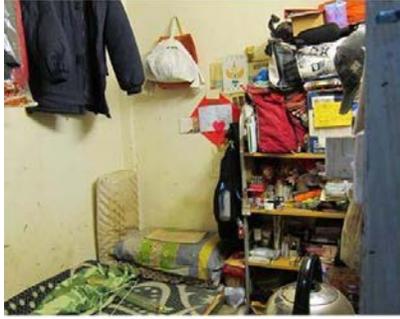
(a) SDU in R1 at Yau Ma Tei

Building number	District	Room area	Combustibles	FLD (MJm⁻²)
R1	Yau Ma Tei	3.7 m ²	a single bed, clothes, small wardrobe, newspaper, carton	556
R2	To Kwa Wan	4.6 m ²	Paper, plastic wardrobe, bunker bed, television, an air conditioner, fan, clothes, table, refrigeration	949
R3	Fanling	4.2 m ²	Paper, plastic wardrobe, bunker bed, table, clothes, fan, curtain	1024
R4	North Point	5.6 m ²	bunker bed, refrigeration, paper, clothes, wardrobe	1326
R5	Sham Shui Po	3.7 m ²	bunker bed, table, clothes, paper, wardrobe, chair	1563
R6	Mong Kok	6.0 m ²	Wardrobe, television, double bed, air-conditioner, small wardrobe, clothes	767
R7	Tai Po	3.7 m ²	Single bed, fan, radio, small wardrobe, newspaper, clothes	576
R8	Hung Hom	6.5 m ²	Bunker bed, table, clothes, wardrobe, computer	787

Figure 1. Combustibles inside SDUs of residential buildings

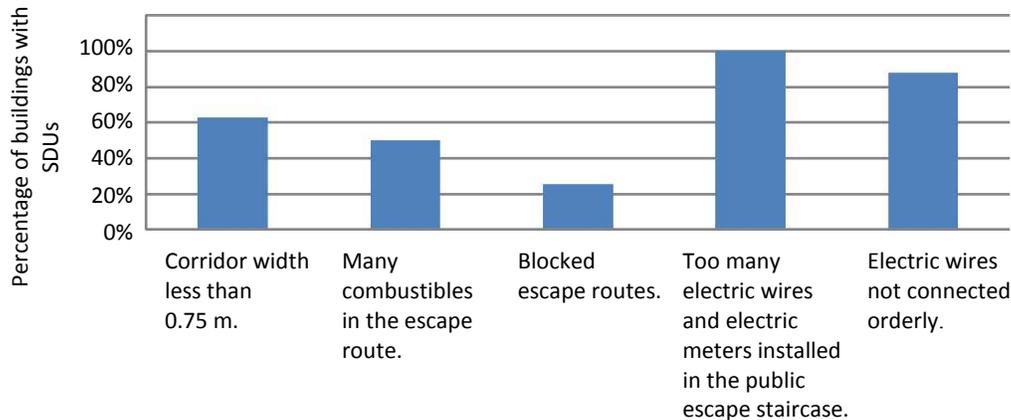
Fire safety problems surveyed are shown in Figure 2. Basically, the problems are:

- The corridor width is less than 0.75 m.
- Many combustibles are placed in the escape route.
- Escape routes are blocked.
- Too many electric wires and electric meters are installed in the public escape staircase.
- Electric wires are not connected orderly because of addition and alteration works.

Figure 2. Observed fire safety problems in SDUs

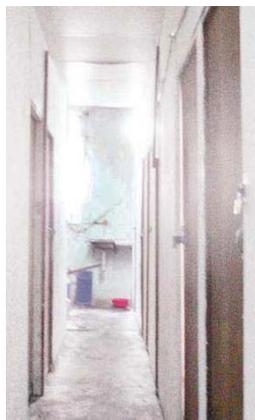
(a) R1

Local regulations (Buildings Department 2011) require that for a flat with less than 3 persons, the clear width of the internal corridor serving the SDUs should not be less than 0.75 m. Narrow corridor violates the regulations and would give difficulty in evacuation. However, narrow corridors are observed in the unit in R1 at Yau Ma Tei and R2 at To Kwa Wan as shown in Figure 3. Since one floor may contain several SDUs, the population density on a floor with SDUs should be much higher than the

population density on a floor without SDUs. A flat with narrow internal corridors and high population density would give (Reax Fire Protection Engineering Services 2014) long evacuation time.

Figure 3. Narrow corridor observed

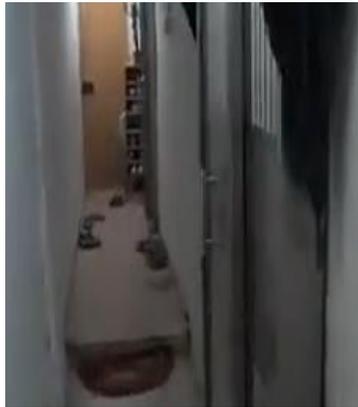
(a) R5 at Sham Shui Po

Many combustible objects are placed in the escape route as in R5 at Shum Shui Po and R4 at North Point as shown in Figure 4. Putting objects in the escape route will not only block the corridor, but it may also increase the rate of fire spread (Cheng and Hadjisophocleous 2011). Most of the objects placed on the corridors and staircases are combustible. Upon igniting those objects, the fire may spread easily and rapidly from one unit to another unit, or from one floor to another floor. Large amount of smoke will be produced to reduce the visibility (Klote and Milke 2002). People might die due to inhaling too much smoke.

Figure 4. Combustibles placed in SDUs

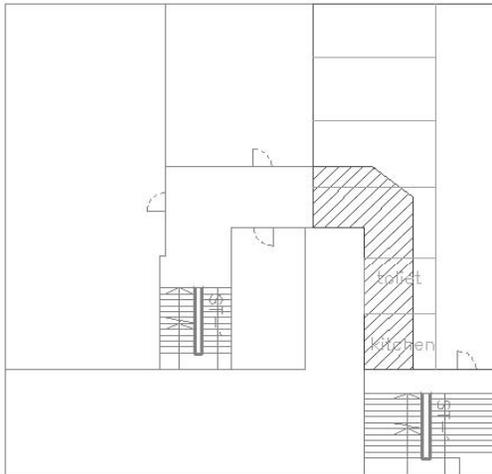
(a) R1 at Yau Ma Tei

Some escape routes are blocked as in R1 at Yau Ma Tei and R2 at To Kwa Wan as shown in Figure 5 on the floor layout plans. As in Figure 5a, the three SDUs can reach both staircases in the original building design. However, another SDU was built

with an illegal partition wall, which blocked the escape route from the other two flats to the staircase. For the case in Figure 5b, the floor in that building was originally built with two large units. However, the two large units are subdivided into several SDUs. The escape route is blocked due to the added doors and partition walls. Although there are two staircases, occupants cannot use the nearby staircases. Blocking the escape route would give long evacuation time which might lead to fatality and injuries. Units with only one staircase are very dangerous.

Figure 5. Blocking of escape route

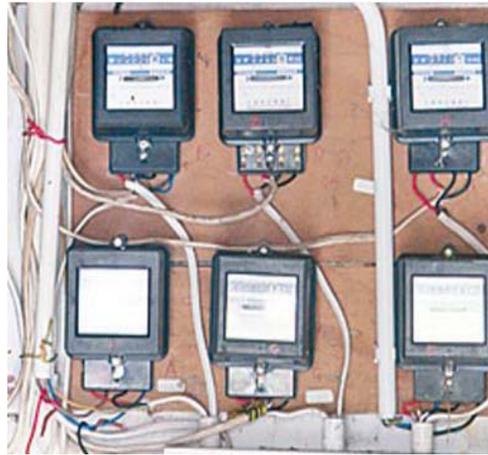
(a) R1 at Yau Ma Tei

Figure 6. Electrical meters

All the eight buildings with SDUs surveyed have many electric meters and electric wires installed in the escape routes or staircases as in R1 at Yau Ma Tei and R6 at Mongkok shown in Figure 6. As observed from the figure, each SDU has its own electric meter for paying the electric bill. Those electric meters may not be installed by registered persons or companies. Further, too many users as indicated by the number of electric meters would cause overload as occupants are having many low quality electrical appliances, such as pirated cellular phones with explosion reported in the past. Note that electrical overload is the main cause of fire as reported in the past fire accidents in SDUs. It can be observed from Figure 6a that electric wires are not connected orderly. Protective coating of electric wires might be ruined to cause electricity leakage.

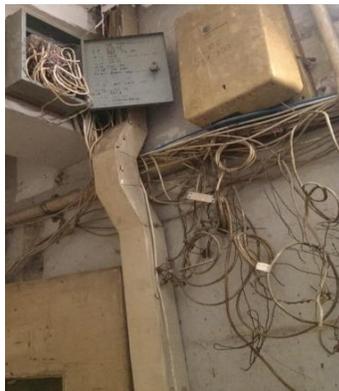
It can be observed that electric wires are not connected orderly in I2 at Tsuen Wan on some floors with SDUs as in Figure 7a. The escape route in an industrial building is wider than that in a domestic building as shown in Figure 7b for I1 at Kwun Tong.

(a) Electric wires in I2 at Tsuen Wan (b) Corridor of SDUs in I1 at Kwun Tong

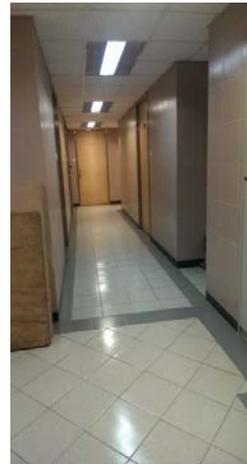
The corridor and escape route for SDUs in industrial buildings are better than those in domestic buildings. In the industrial building, the corridor of the floor with SDUs complied with the requirement of minimum clear width of the internal corridor. The width of the corridor is more than 1.5 m as shown in Figure 7b. No objects were placed in the escape route.

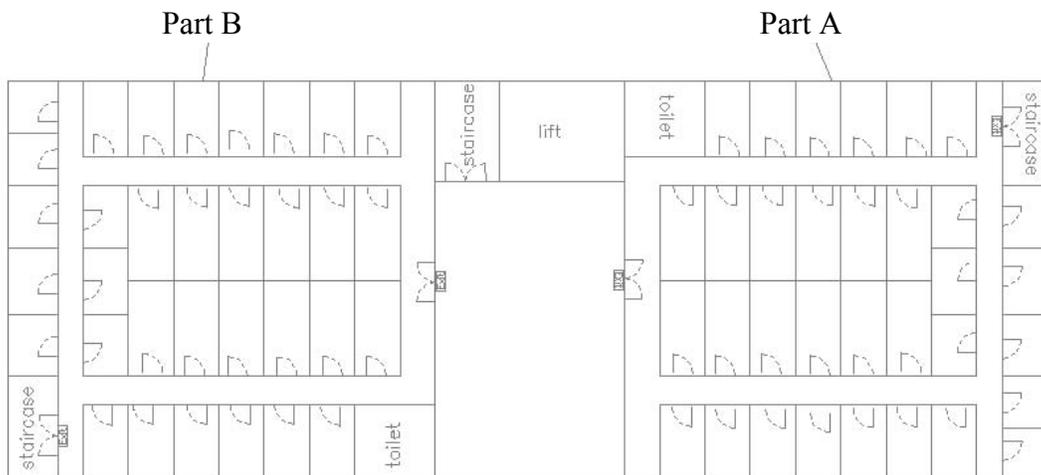
However, the escape route design did not satisfy the requirement (Buildings Department 2011; Fire Services Department 2012) that the length from any living unit to the escape staircase should not be longer than 18 m. As the industrial building has a large floor area, some SDUs have escape route over 18 m (Cherwell Fire Safety Limited 2011). As in Figure 8 on the SDU at Kwun Tong, the floor is separated into two parts, each with 33 SDUs. The population of the floor is high. On that floor, the escape route in some SDUs is more than 18 m. The required evacuation time will be extended for high occupant loading. Although the situation of the public corridor of the floor with SDUs in industrial building is better than that in domestic building, the escape route design failed to comply with local regulations.

Figure 8. Layout plan of a floor with SDUs in the surveyed industrial building I1 at Kwun Tong
