Insulated Concrete Masonry Below-Grade Walls

A report prepared by

N. Repka and B. Kasal

March 2008

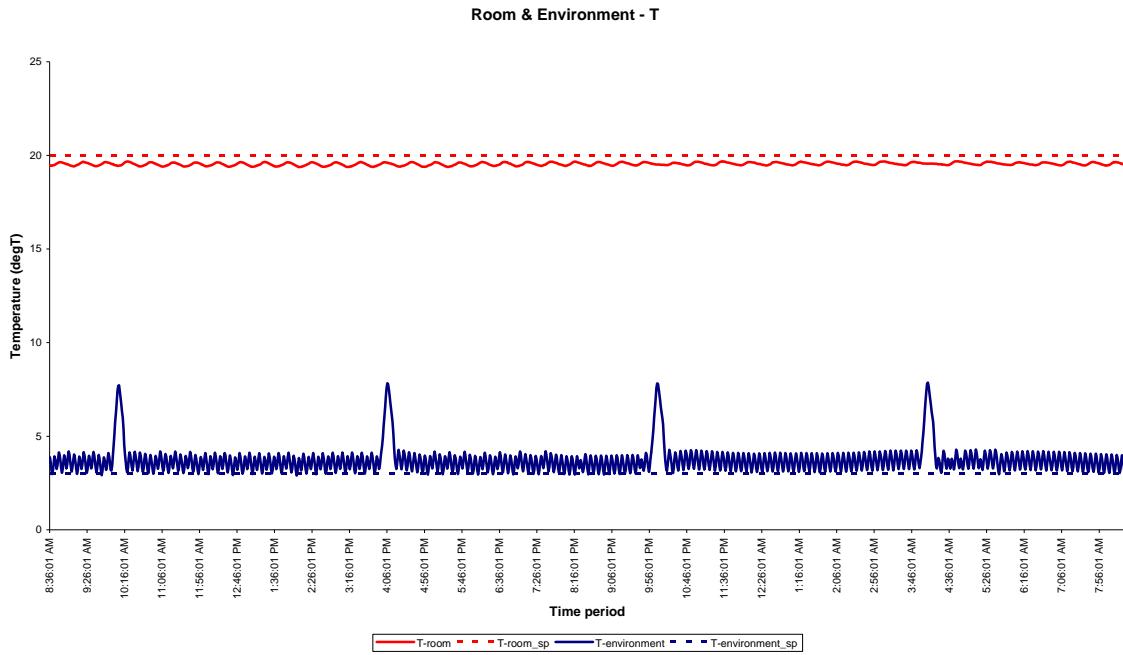
Figure 3-1: Example of temperature control

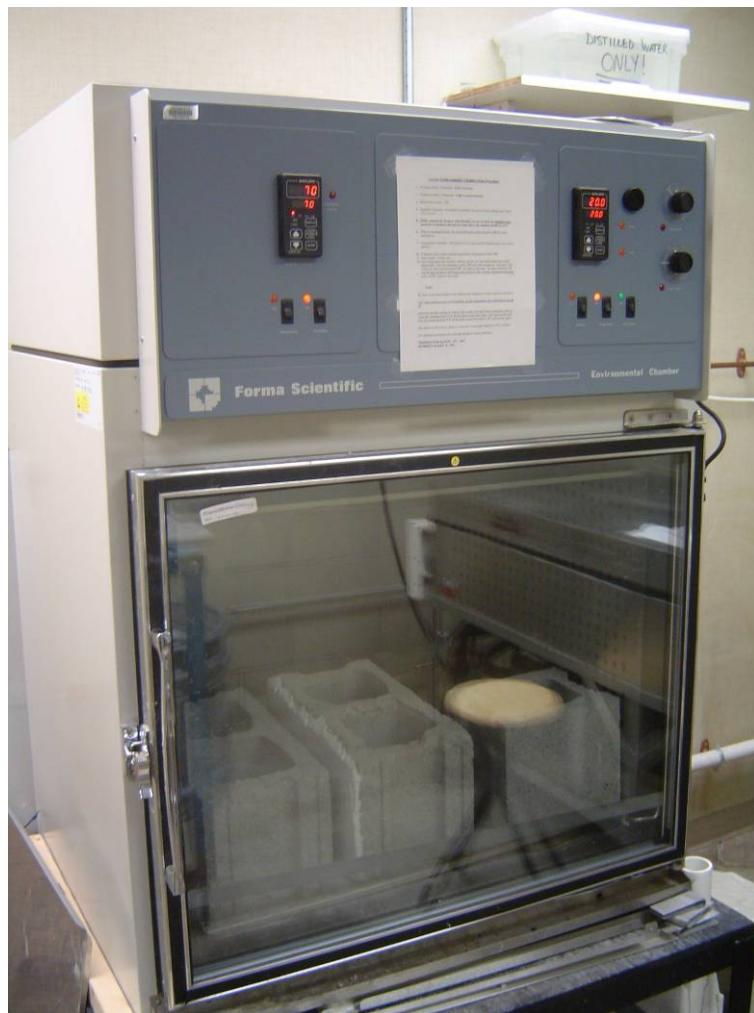
Figure 4-1: ThermoForma 3911 environmental chamber

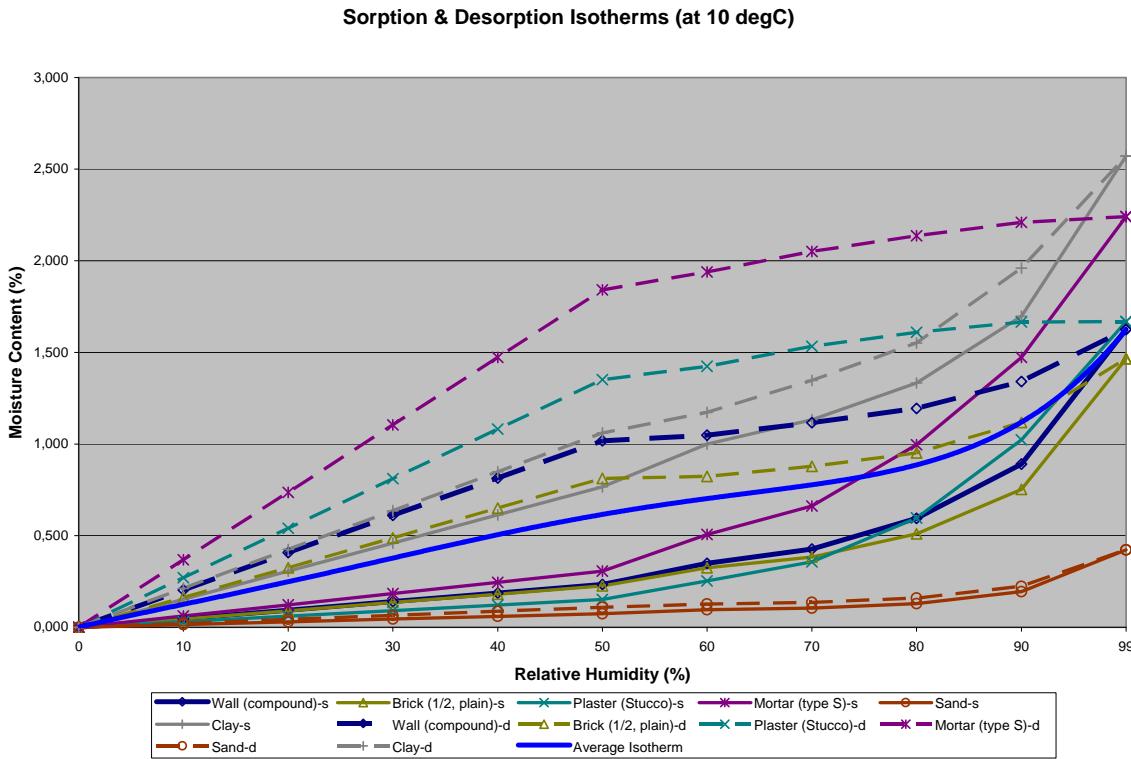
Figure 4-3 shows the sorption and desorption isotherms at 10°C (50°F) for each tested material. Dry samples were subjected to increased 50% RH and the RH was increased in 10% steps until the upper RH limit (about 99%) was reached. Then the RH in the chamber was stepwise reduced (again in decrements of 10%) until 50% RH was reached. At each step (5 days/step) specimens were weighed.

Figure 4-3: Sorption and desorption isotherms at 10 °C (50 °F)

From Figures 4-3 and 4-4 it is evident that the lower moisture content is attained by sand compared to clay.

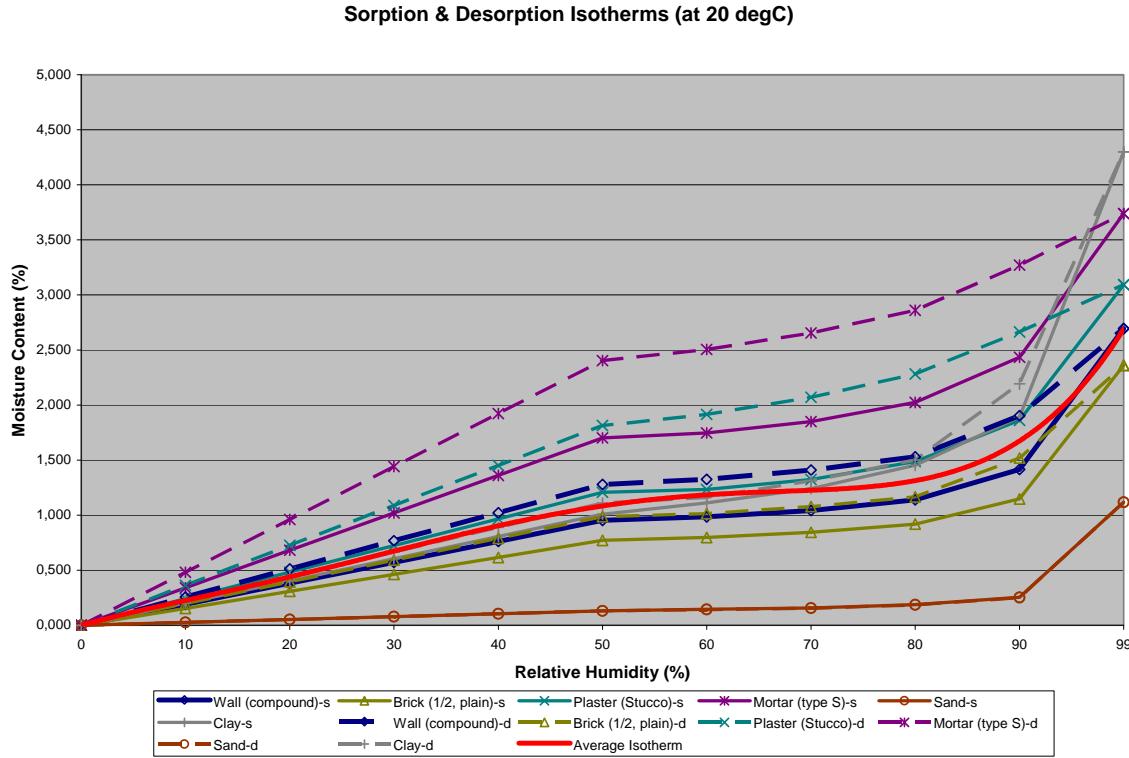
Figure 4-4 shows sorption and desorption isotherms at 20 °C (68 °F) for individual materials. Calculated properties of the wall assembly are also shown. The bold red (10 °C; figure 4-2) and blue (20 °C; figure 4-2) isotherms show moisture content of parged wall without hysteresis. Regression equations can be used to estimate the overall moisture contents of the wall (note that the formula applies to this test assembly only):

For example, at 100 % of RH and 10 °C the MC of the parged wall is 1.63 % of its dry weight. At about 100 % of RH and 20 °C the MC of the parged wall is 2.69 %.

Figure 4-4: Sorption isotherms at 20 °C (68 °F)

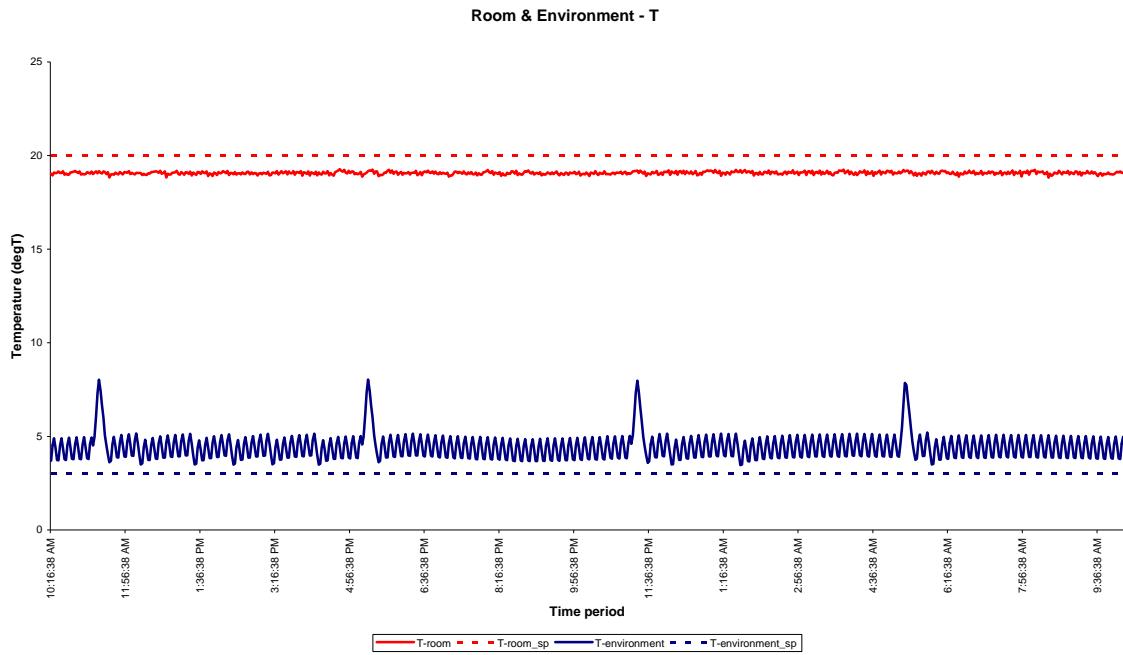
Figure B-8: Temperature of the room and environmental side during S1-Alt1

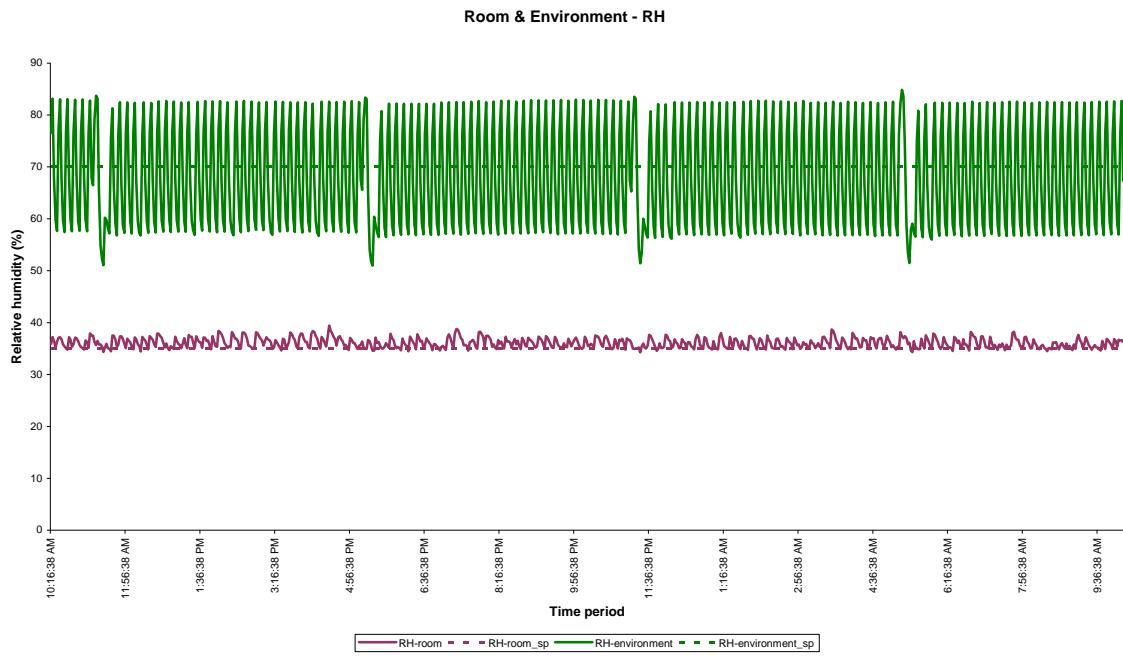
Figure B-9: Relative humidity of the room and environmental side during S1-Alt1

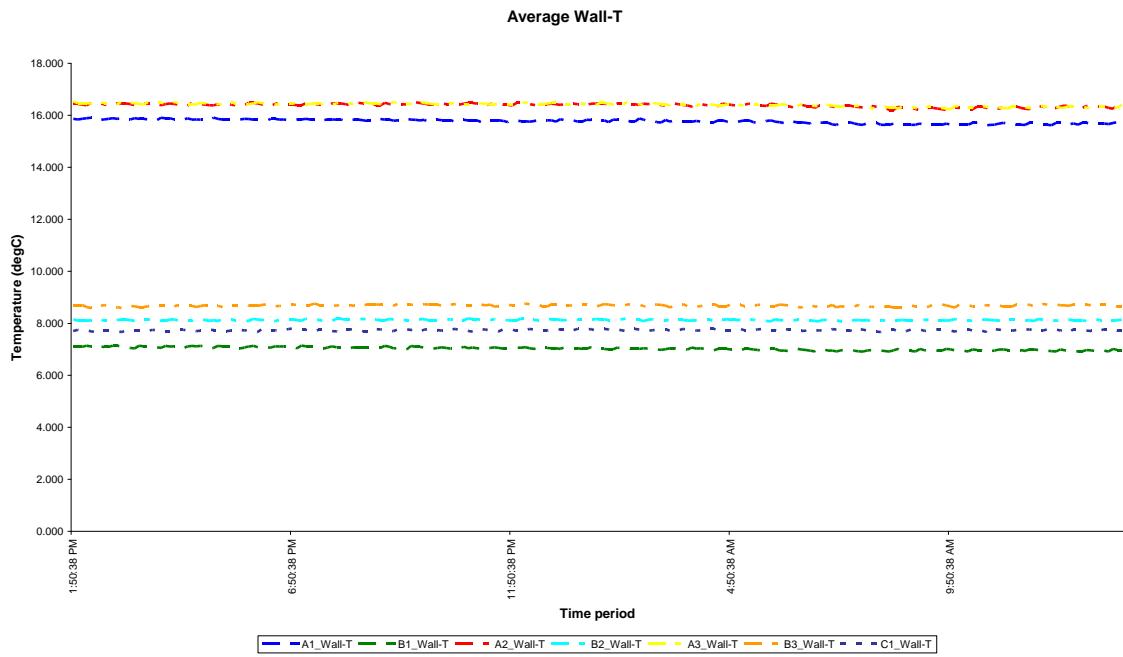
Figure B-12: Average wall temperature of S1-Alt2

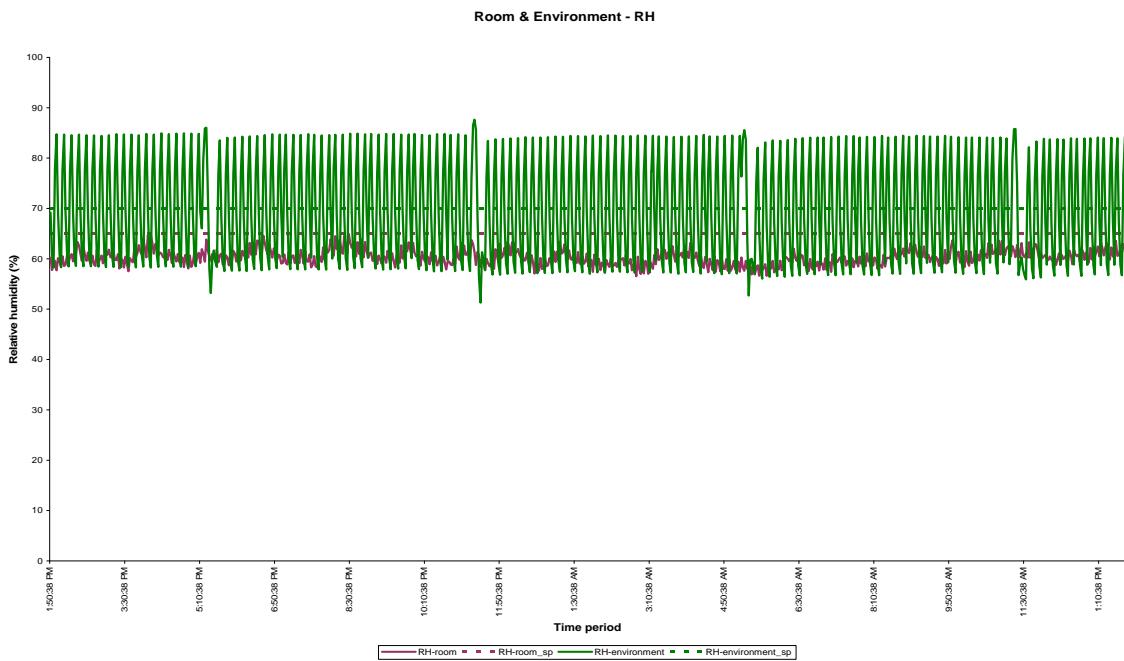
Figure B-18: Relative humidity of the room and environmental side during S1-Alt2

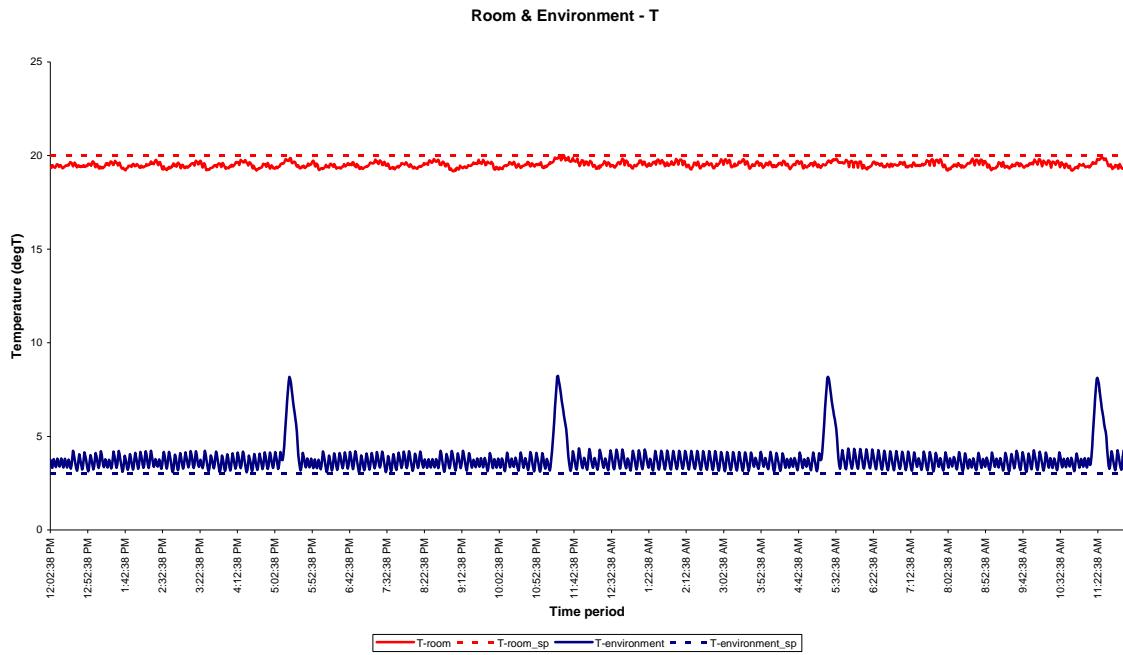
Figure B-26: Temperature of the room and environmental side during S1-Alt3

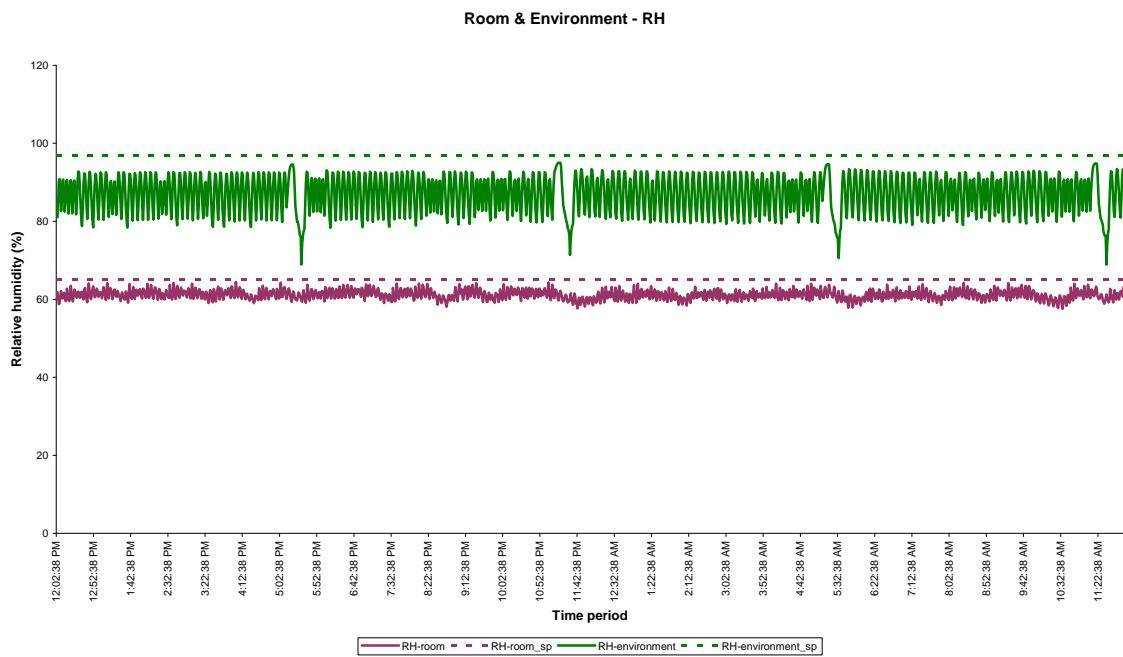
Figure B-27: Relative humidity of the room and environmental side during S1-Alt3

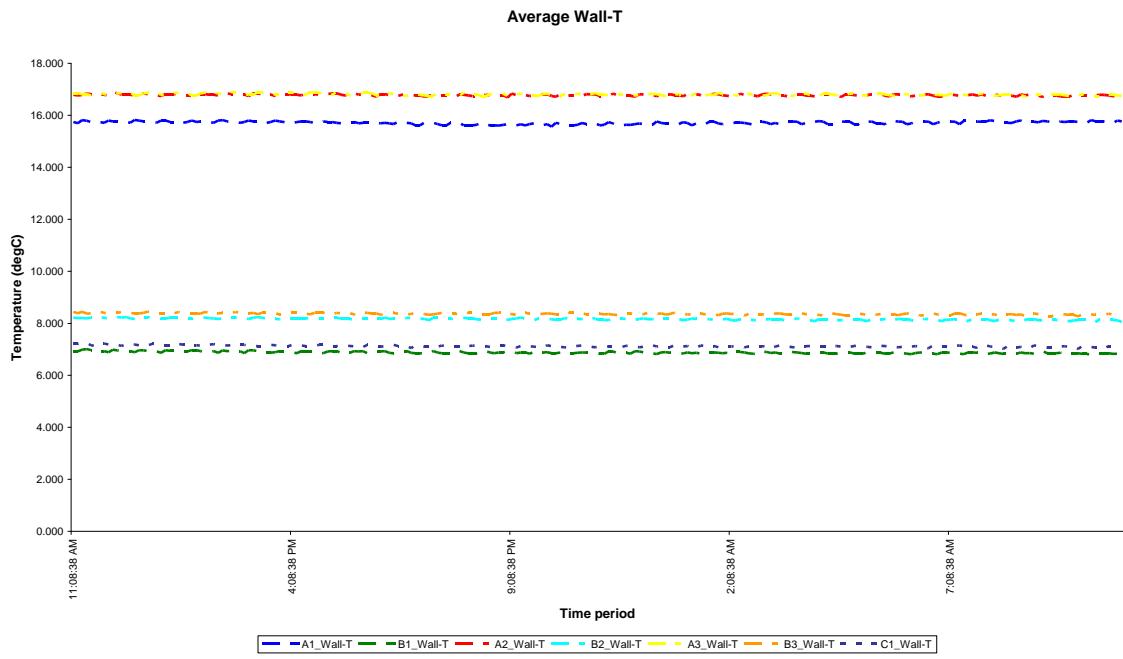
Figure B-30: Average wall temperature of S1-Alt4

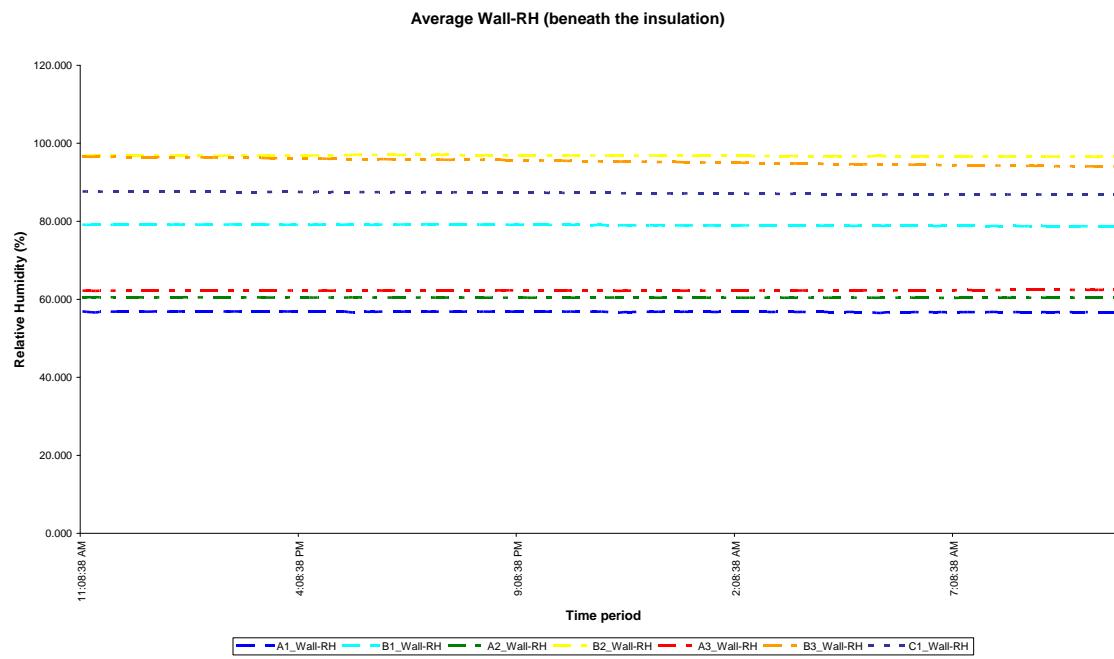
Figure B-34: Average wall relative humidity beneath the insulation of S1-Alt4

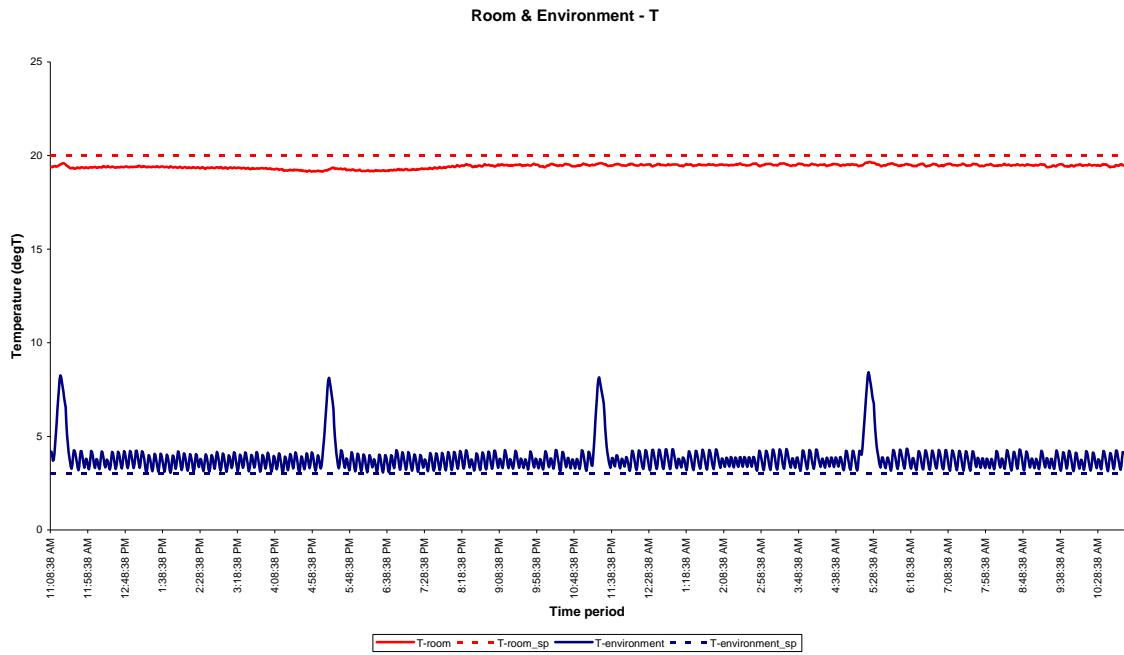
Figure B-35: Temperature of the room and environmental side during S1-Alt4

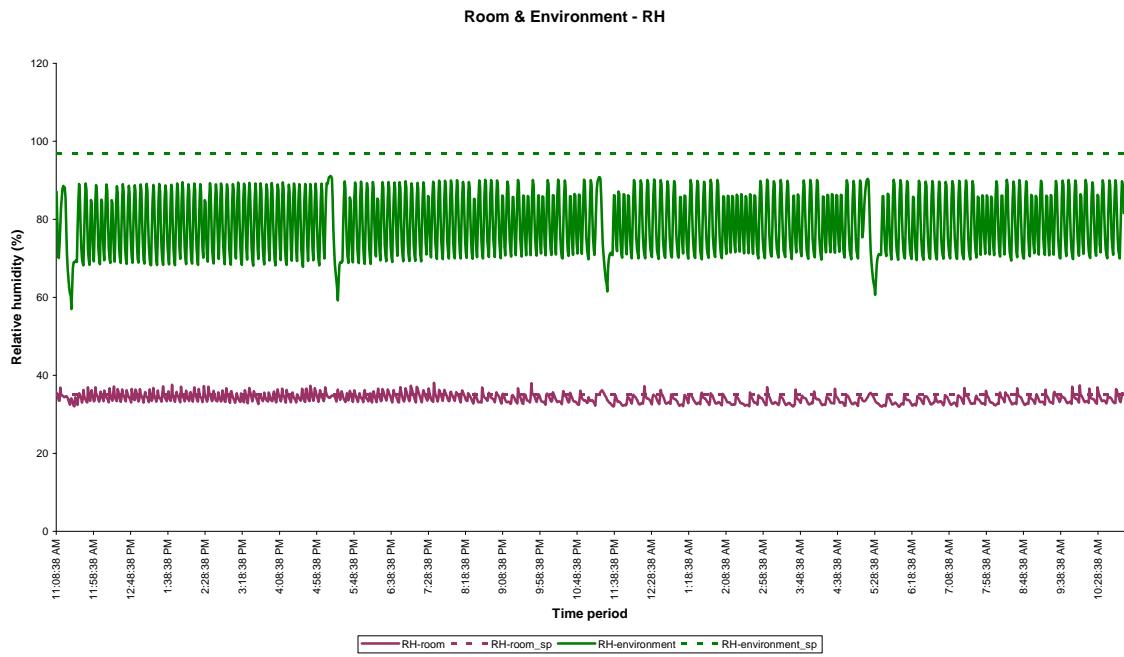
Figure B-36: Relative humidity of the room and environmental side during S1-Alt4

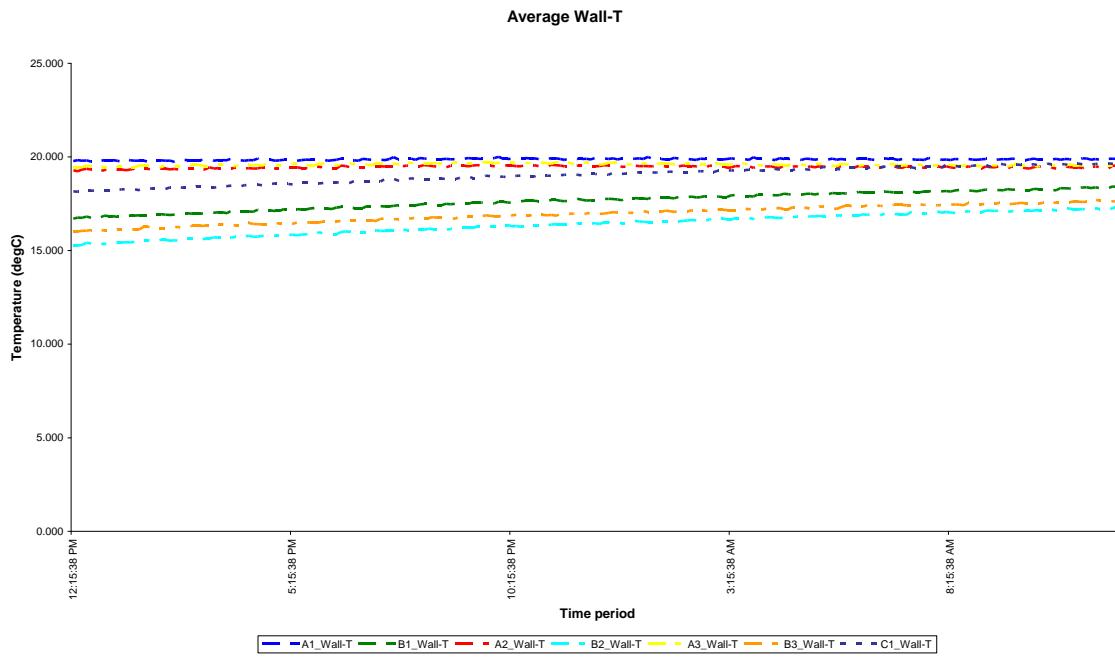
Figure B-39: Average wall temperature of S1-Alt5

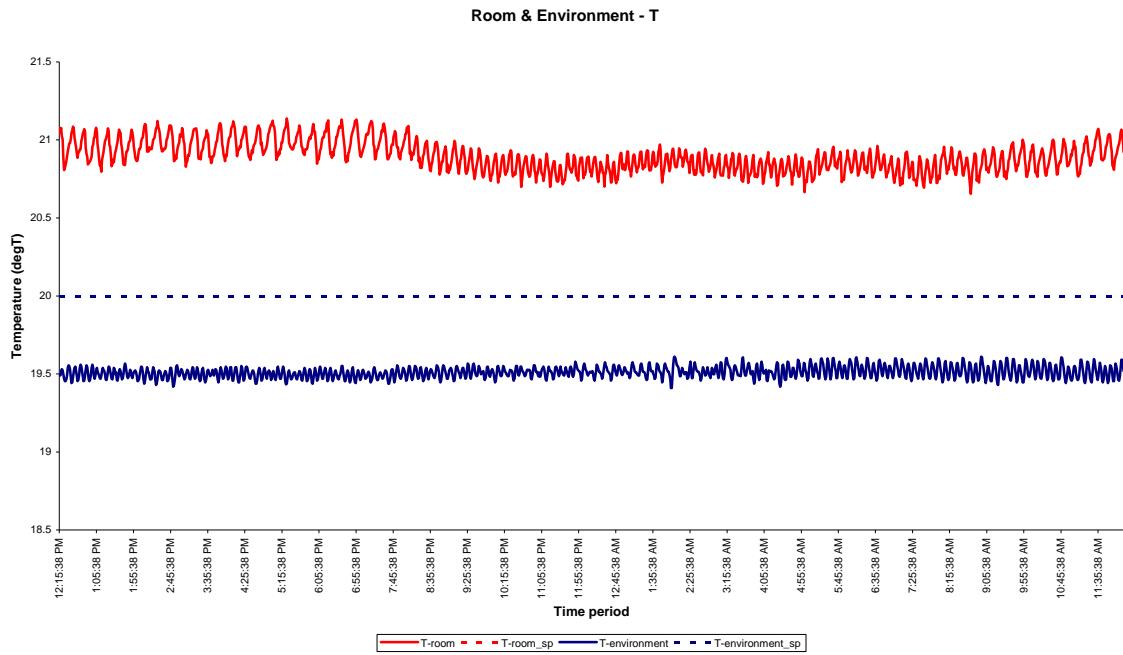
Figure B-44: Temperature of the room and environmental side during S1-Alt5

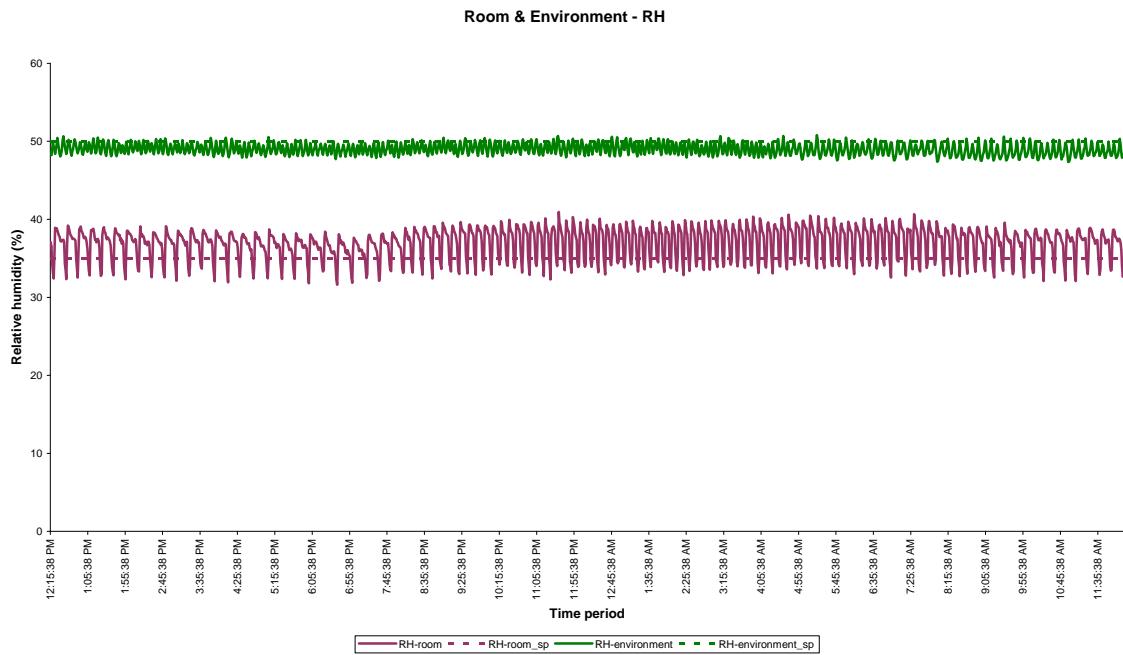
Figure B-45: Relative humidity of the room and environmental side during S1-Alt5

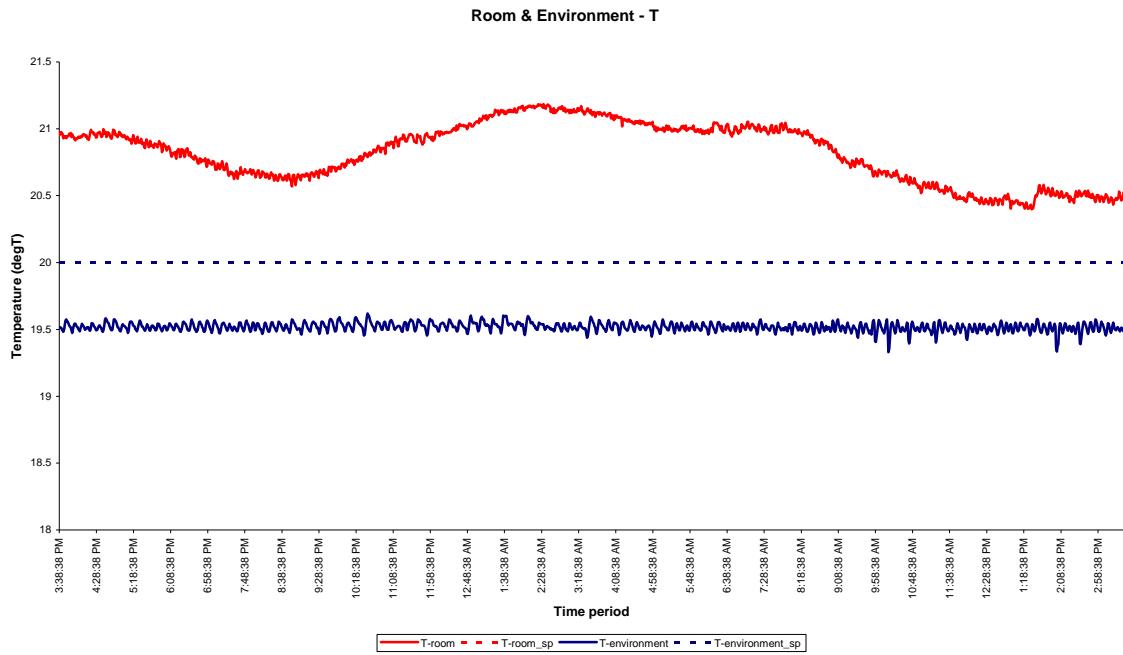
Figure B-53: Temperature of the room and environmental side during S1-Alt6

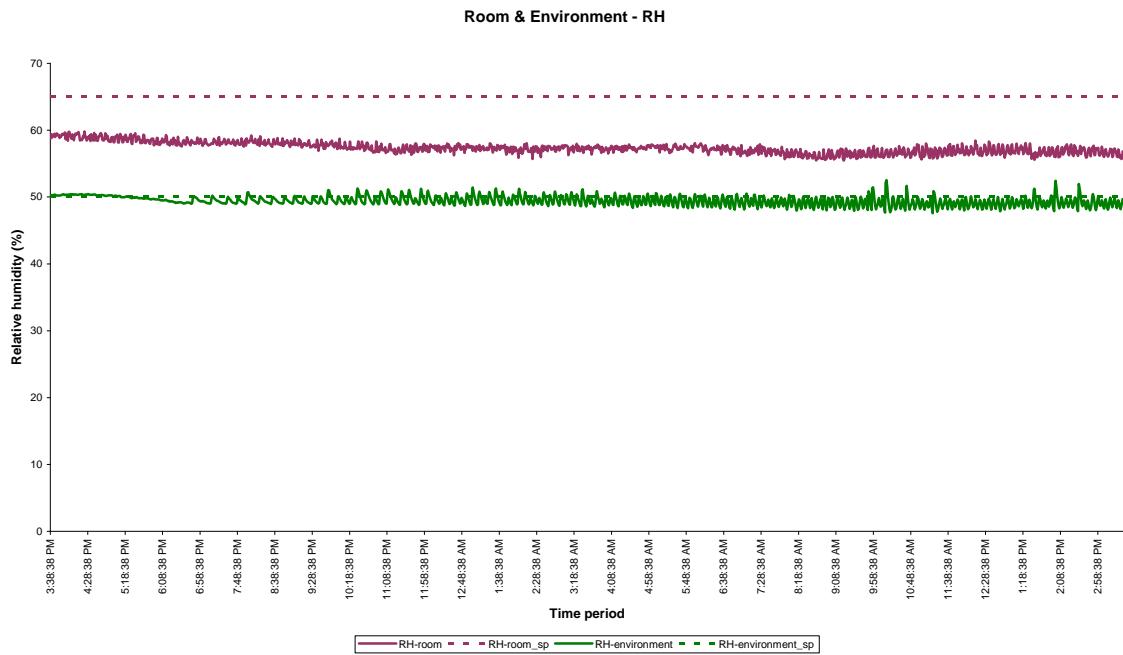
Figure B-54: Relative humidity of the room and environmental side during S1-Alt6

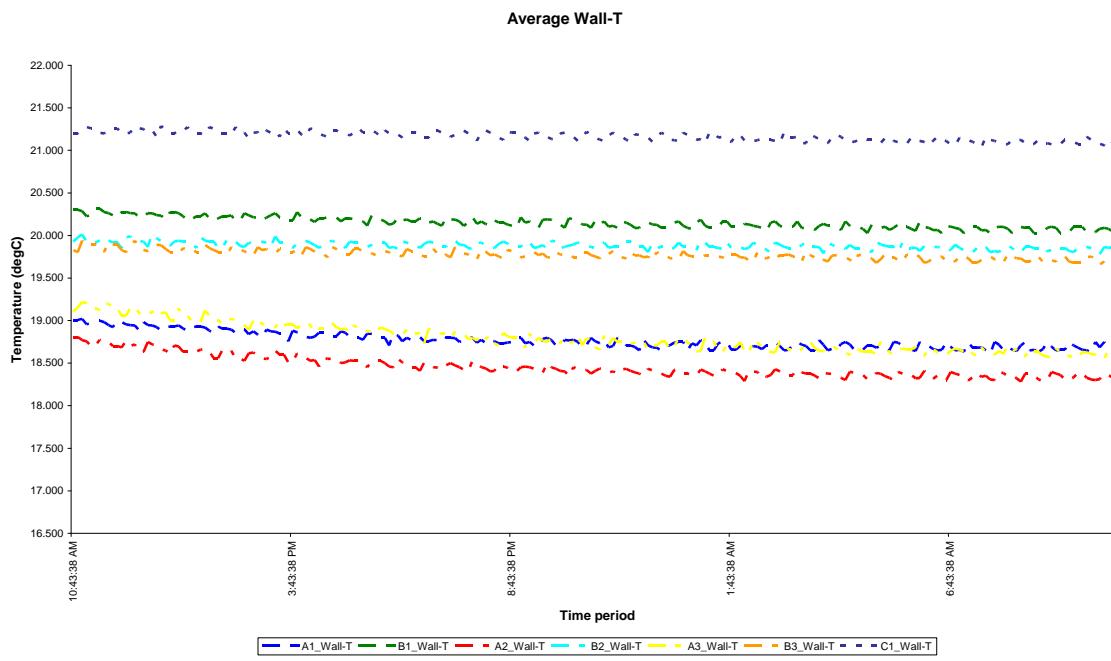
Figure B-57: Average wall temperature of S1-Alt7

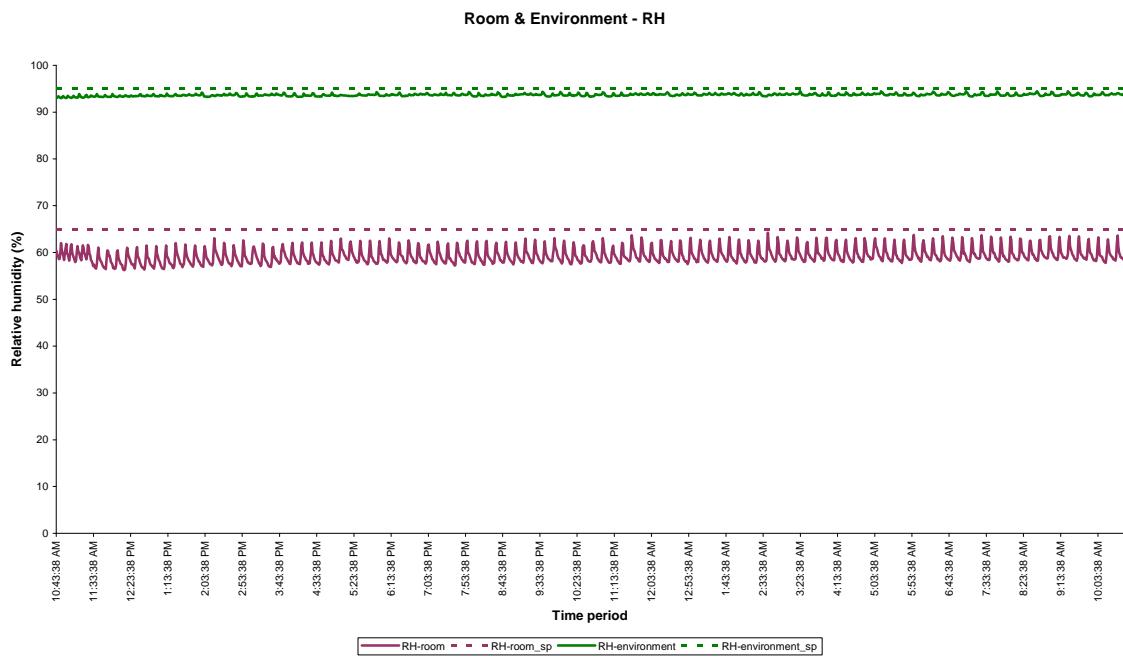
Figure B-63: Relative humidity of the room and environmental side during S1-Alt7

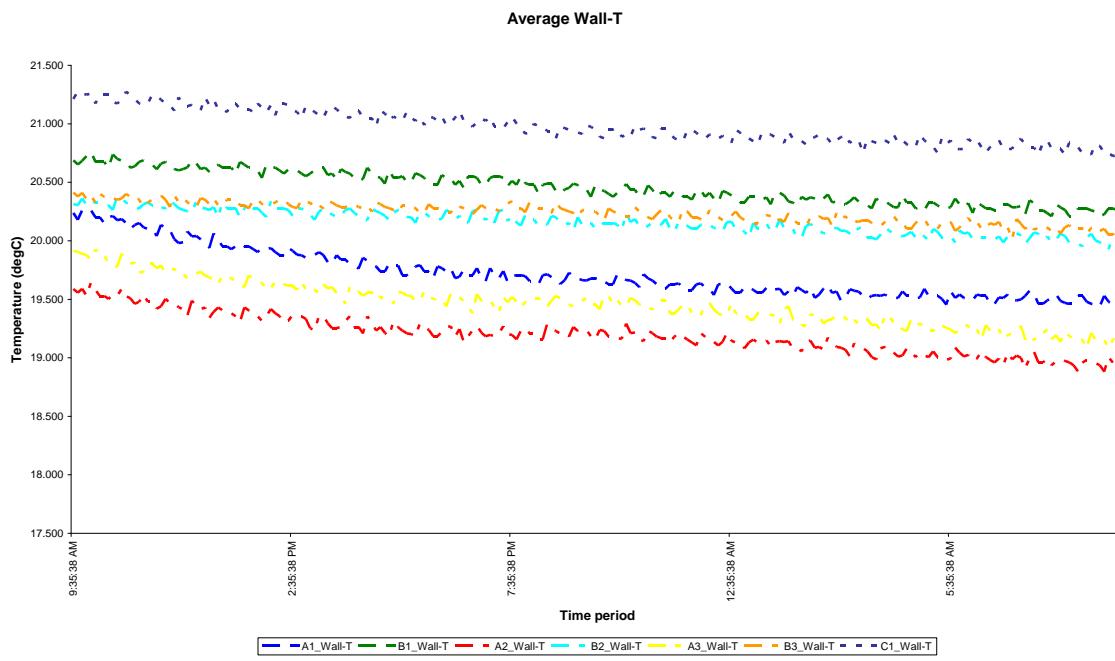
Figure B-66: Average wall temperature of S1-Alt8

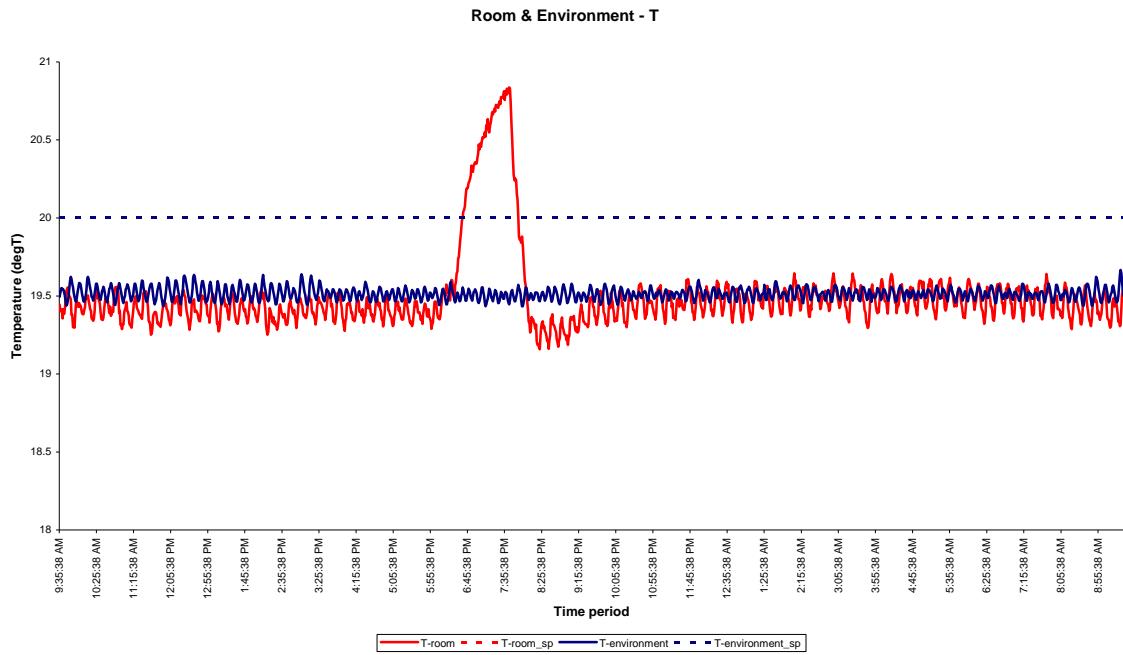
Figure B-71: Temperature of the room and environmental side during S1-Alt8

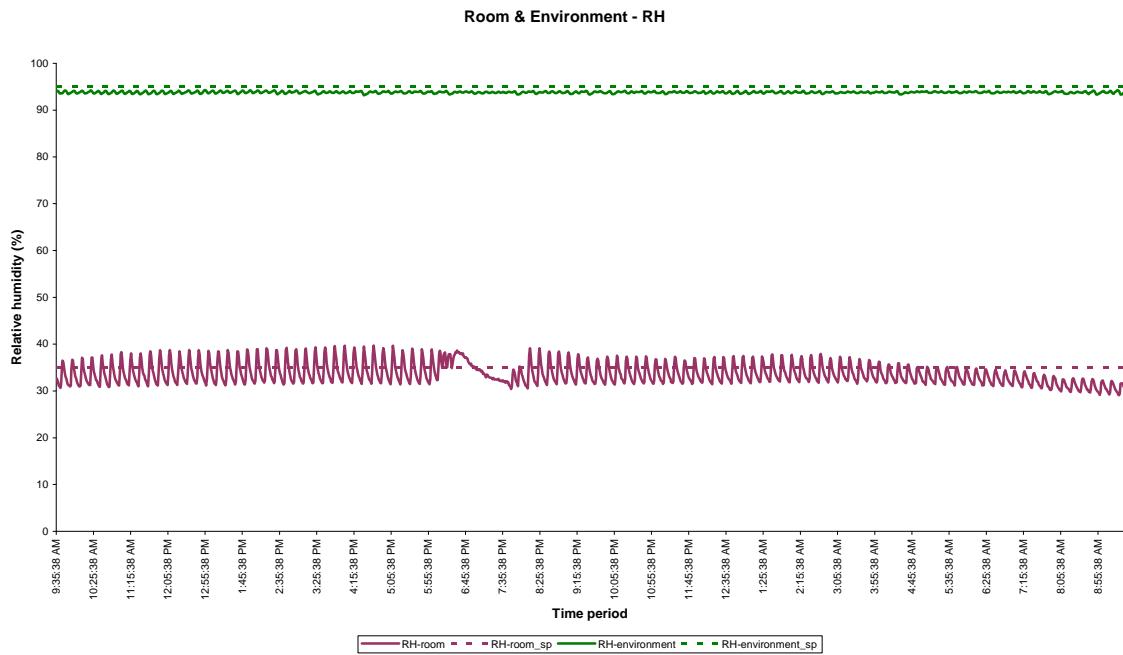
Figure B-72: Relative humidity of the room and environmental side during S1-Alt8
