Wind Uplift Capacity of Foam-Retrofitted Roof Sheathing Subjected to Water Leaks

D. B. Roueche¹, J. Eixenberger², D. O. Prevatt¹, K. E. McBride¹, F. J. Masters¹

ABSTRACT

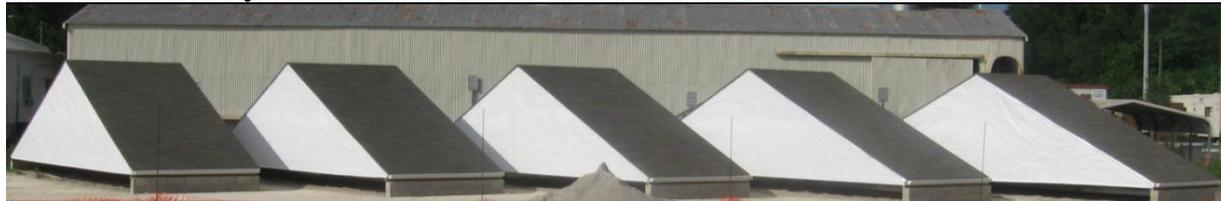
Table 1: Summary of Test Variables – Phase I

Roof 1	Roof 2	Roof 3	Roof 4	Roof 5
No Retrofit	Type II Retrofit	Type II Retrofit	Type III Retrofit	Type III Retrofit
Leak Gaps	Leak Gaps	No Leaks	Leak Gaps	No Leaks

Full details of the Phase I study are available elsewhere (McBride, 2011) and will not be discussed at length here. The objective of the study was to identify if moisture buildup occurred and if so, quantify the effect it had on the uplift capacity of the roof sheathing. Both large-scale and small-scale testing was utilized to evaluate the effect of moisture on the ccSPF-to-wood bond. In the large-scale tests, five full-scale attic roofs were constructed out of wood trusses and OSB sheathing, and were retrofitted as shown in Table 1.

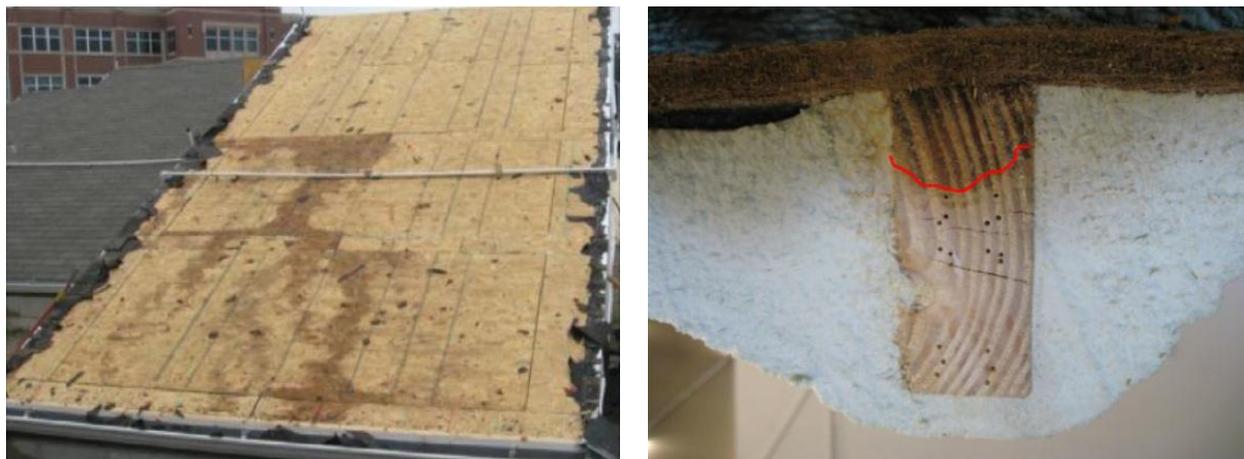
(a) Moisture Buildup in Sheathing (b) Moisture Buildup in Framing Members
Figure 2. Observed Moisture Buildup in Retrofitted Roofs with Leaks

A hundred and four ½” leak gaps were cut into three of the five roofs, all of which were then exposed to both natural and simulated rainfall for 150 days. Moisture contents of the truss top chords, temperatures and humidity were continuously monitored for the duration of the exposure period. After the completion of the exposure period, eight 4’x8’ panels were harvested out of each roof and tested to failure using a Pressure Loading Actuator (PLA) and steel chamber. Significant moisture buildup did indeed occur in the retrofitted roofs with leaks (shown in Figure 2) and not in the non-retrofitted roof, which also had leaks, but the moisture had no observable effect on the uplift capacities.

Increased moisture contents in wood did not produce statistically significant changes in panel failure pressures over the 150-day weathering period. However, the moisture content in leaking ccSPF-retrofitted roof panels increased at a faster rate than in leaking un-retrofitted roof panels. In fact, the un-retrofitted roof did not see any sustained water content values above 22%. The moisture contents in ccSPF-retrofitted roofs with leaks often exceeded thresholds for fungal decay and strength loss, with moisture contents above 70% observed in Roof 2 and 60% in Roof 4 truss members. Truss moisture contents above 20% were observed for over three months in both Roofs 2 and 4. Although wood degradation/rot was not measured during this experiment, the results of this Phase I study demonstrate that the presence of the impermeable ccSPF layer on

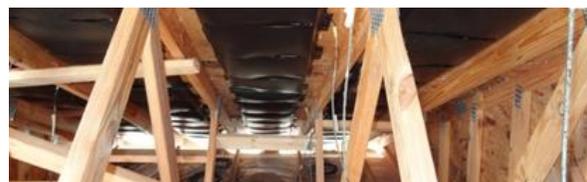
(a) Cross-section View

(b) Air Gap Prior to ccSPF Installation

Figure 3: Details of the Air Gap in Roof 3

Two techniques were evaluated for their effectiveness in minimizing moisture buildup and drying times in ccSPF-retrofitted roofs. Roof 2 used a self-adhered waterproofing membrane at the top surface of the wood sheathing in lieu of the felt used in standard roof systems. It was expected that the self-adhered membrane would limit the amount of moisture entering the roof system through the leaks, but there were also concerns that its use would prevent any moisture from leaving the roof sheathing due to the presence of vapor barriers on both sides of the sheathing. Roof 3 utilized a vented approach, whereby an air gap was provided at the underside of the sheathing through the use of a plastic vent system, installed prior to the installation of the ccSPF. The dimensions and installed view of the air gap is shown in Figure 3.

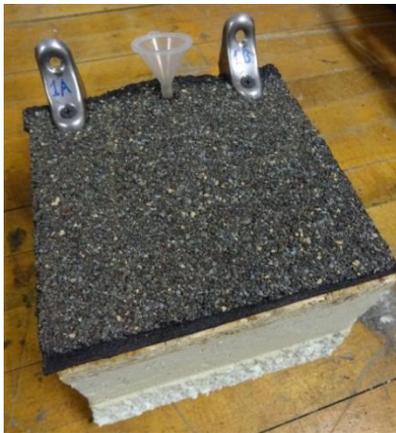
Figure 5: Typical sample prior to testing

Samples consisted of 6"x6" sheathing specimens retrofitted with a 3" ccSPF layer as shown in Figure 5. Felt underlayment and shingle samples were fastened to the top of the samples to represent true roof conditions and the edges were sealed with a waterproofing sealant to restrict moisture absorption to the top surface only. Samples were oriented on a 6:12 slope and exposed to a continuous drip of water at a rate of 2mL/min for 24 hours in accordance with a modified ASTM D1037 procedure. Mass, dimensions and moisture contents of the samples were taken before and after the exposure period. Moisture contents were monitored for 96 hours after the exposure period ended using a Delmhorst BD-2100 Handheld Moisture Meter with 5/16" contact pins. Each sample was subdivided into nine subsections, 2"x2" as shown in Figure 6, when taking moisture contents in order to better quantify the distribution of moisture across the samples. Testing was performed in a conditioned environment with a temperature of 76°F and 45% RH.

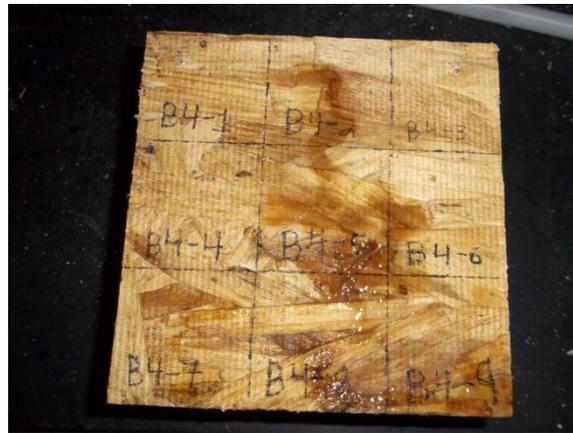
Figure 6: Nine subsections to each sample

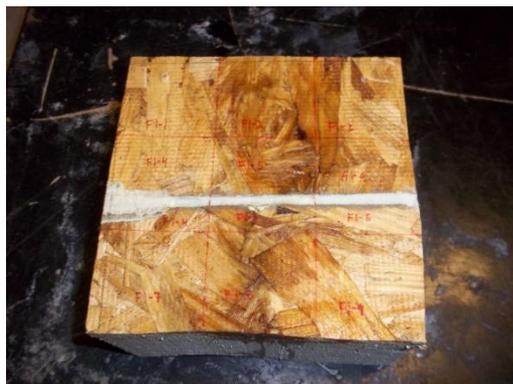
Figure 9: Sample with Horizontal Joint (HJ)

The effect of ccSPF on moisture accumulation at joints was also examined using samples with both horizontal and vertical joints, shown in Figures 9 and 10. In addition to the sheathing moisture contents monitored in all samples, moisture contents were also measured at ½” depths

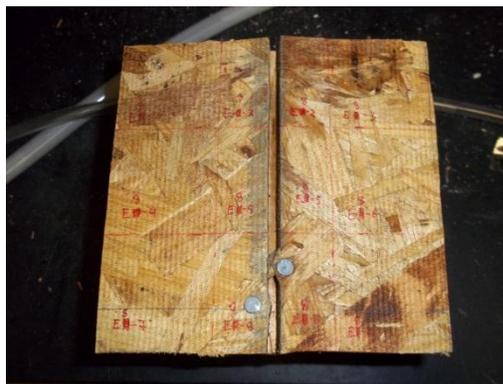
Figure 10: Sample with Vertical Joint (VJ)

in eight locations along the exposed surface of the framing members present in samples with vertical joints. A summary of the results for samples with joints is given in Table 7.
