# **Energy Code Enforcement and Compliance in Pennsylvania: Lessons from the Field**

July 2008

MikeTurns

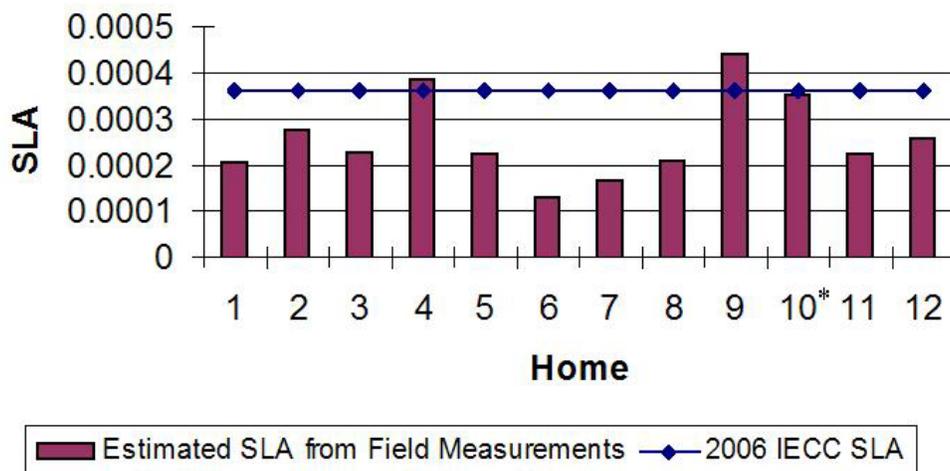
**Figure 4.2: Sample home infiltration compared to 2006 IECC Reference Home**

Figure 4.2 shows estimated infiltration rates, based on blower door tests, of twelve homes compared with the infiltration rates used in the standard reference design in the 2006 IECC Simulated Performance Alternative path (Chapter 4, Section 404). The bars on the graph represent the estimated SLA of the twelve homes in the sample. The line represents the SLA (0.00036) used in the 2006 IECC Standard Reference Design (reference home).

Two homes stand out from the rest in Figure 4.1 and three homes stand out in Figure 4.2. One home (#10) that tested fairly poorly was a four-story townhouse in which there was no blocking along the tops of shaft walls to prevent air infiltration and exfiltration from/to the attic. In addition, the home was constructed with open web floor trusses, which allows air to flow more readily from exterior leaks throughout the whole floor assembly.

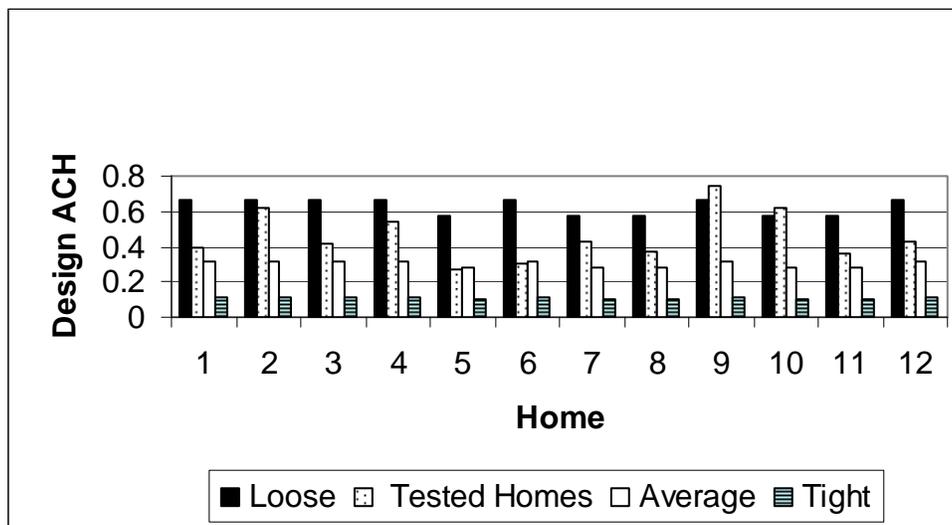
**Figure A1: Sample Home Calculated Estimated Design Heating Infiltration Rates vs. Manual J Default Infiltration Rates**

Figure A1 shows comparison of the estimated design infiltration rates for the sample homes in this study with default rates found in Manual J. Estimated design infiltration rates for sample homes were calculated by TECHTITE software using blower door test data and the calculation procedure found in the ASHRAE Handbook of Fundamentals Chapter 27 (Ventilation and Infiltration) and Manual J. Using this interpretation, all of the homes tested in this study would be consider Average to Loose, with most being closest to Average.
