## **A Study on Residential Fires due to Electrical Faults in Hong Kong**

### **ABSTRACT**

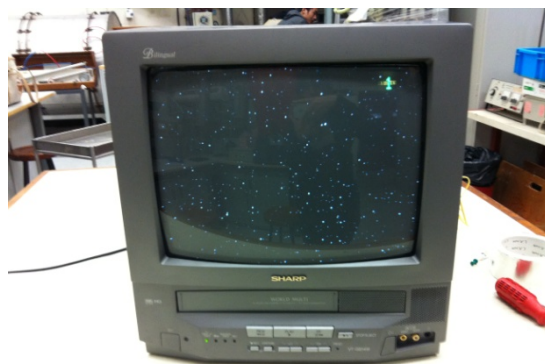
For studying the possibility of ignition of a television by itself, a television set (Lee 2012) with a video recorder as shown in Figure 1 will be used for investigation. It is a common type of television in residential flats appeared in 1990s. A layer of dust is accumulated on the outer shell as it has not been used for a long time. Therefore, dusty condition can also be demonstrated.

**Figure 1. The television set studied**
